Asbestos Incident Inspection

Asbestos Incident Inspection (NOT FOR CONSTRUCTION)			
Report No :	06032017-01 Ver3		
Address:	Jaeger Building 1, Building 61 ANU Action ACT		
Prepared & Approved By :	<table border="1" style="width: 100%;"> <tr> <td style="width: 30%;">B.Williams LAA000169</td> <td style="width: 70%; text-align: center;"> </td> </tr> </table>	B.Williams LAA000169	 
B.Williams LAA000169	 		
Date of Sampling:	<p>6th March 2017</p> <p>9th March 2017 Ver 2</p> <p>15 March 2017 Ver 3</p>

Re: Room B6 Jaeger Building 1, Building 1 ANU Acton ACT

Ref: 06032017-01 Ver 3

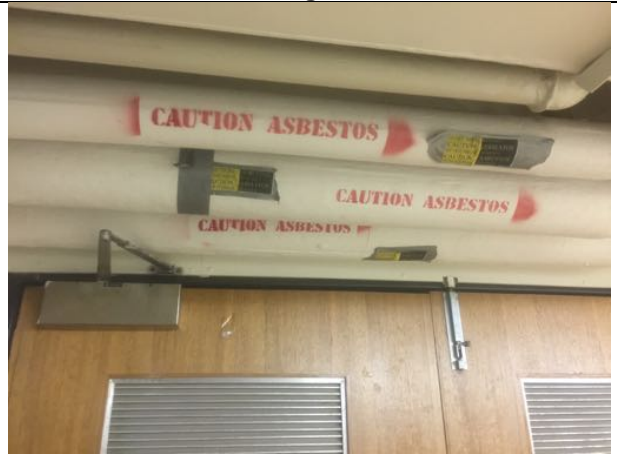
Fig 4

The inspection found that several sections of the pipe lagging in the room was Asbestos, these were found to be clearly labeled (fig 2 to 5)

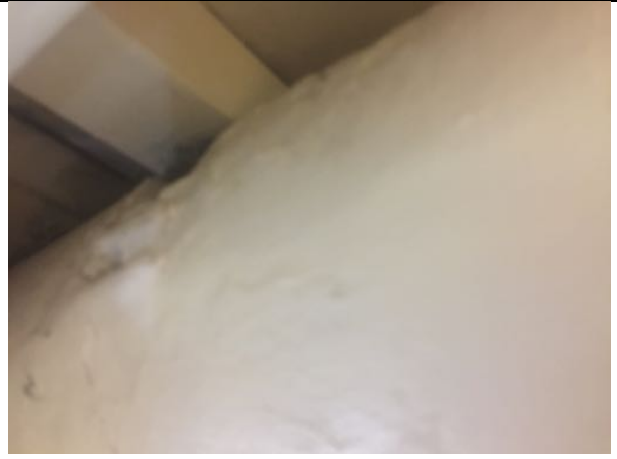
Fig 6

Several areas of the pipe lagging was found in a poor/damaged condition, areas around the hangers & joins were visibly damaged. (fig 6 to 11)

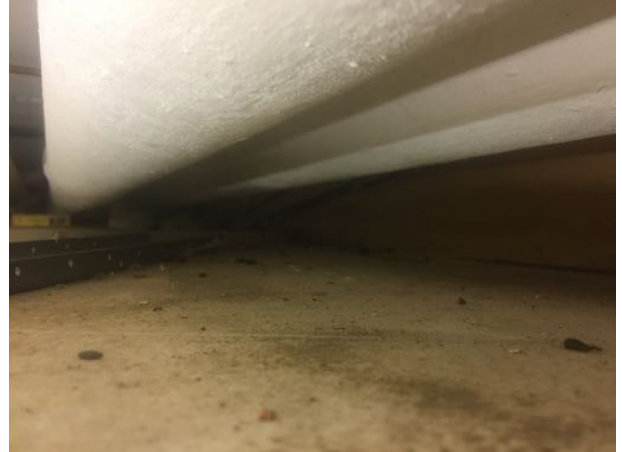
Fig 22

Dust & debris was visible throughout the room below areas where the asbestos pipe lagging was in a poor condition, sampling was conducted in 6 sections of the room to check for the presence of loose asbestos fibres in the dust. (fig 13 to 23)

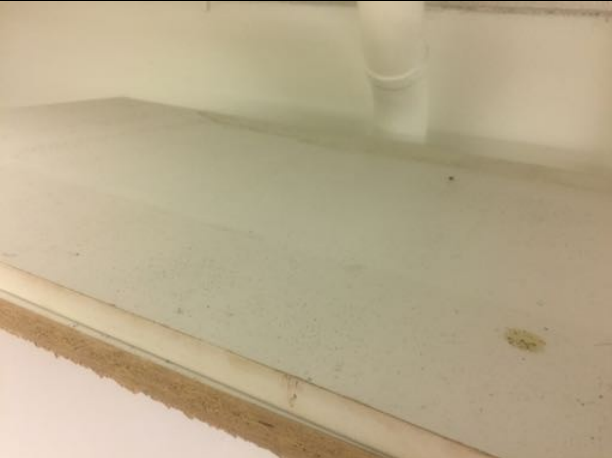
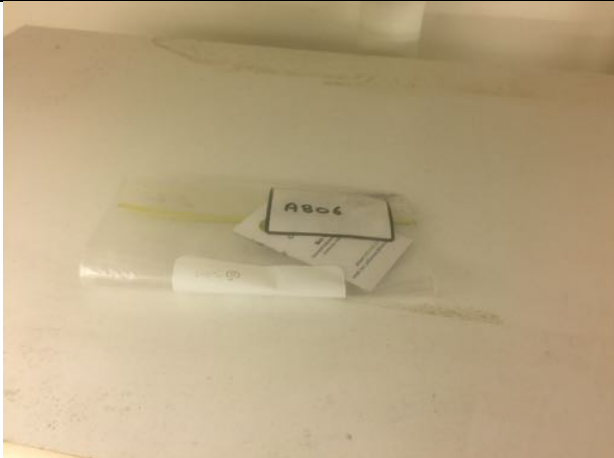
Sample Number		A806				
Date of Sampling		6/3/17				
Location of Sampling		Dust off white cupboard				
Sample Result		No Asbestos detected in sampled area				
Sample Risk Score		-				
Asbestos Fibre Type	Surface Treatment	Product Type	Extent of Damage	Likelihood of Disturbance	Risk	Action Rating
-	-	-	-	-	-	-
Comments & Recommendations			Due to other samples restrict access Removal or repairs of pipe insulation in room Environmental clean of entire room			
Sample Photos

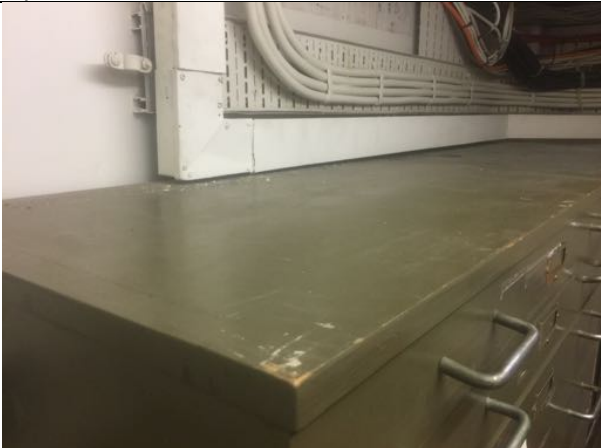
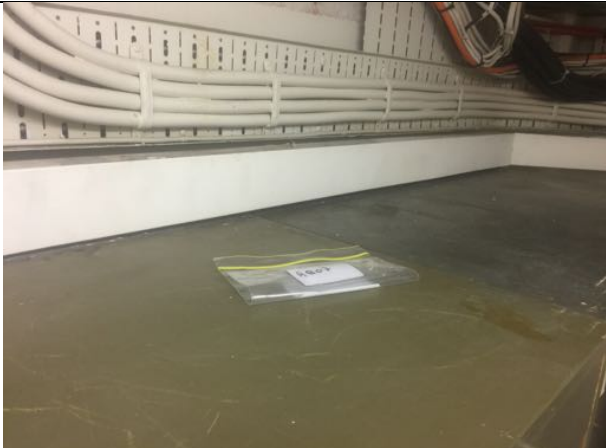
Sample Number		A807				
Date of Sampling		6/3/17				
Location of Sampling		Dust off green cupboard				
Sample Result		No Asbestos detected in sampled area				
Sample Risk Score		-				
Asbestos Fibre Type	Surface Treatment	Product Type	Extent of Damage	Likelihood of Disturbance	Risk	Action Rating
-	-	-	-	-	-	-
Comments & Recommendations			Due to other samples restrict access Removal or repairs of pipe insulation in room Environmental clean of entire room			
Sample Photos

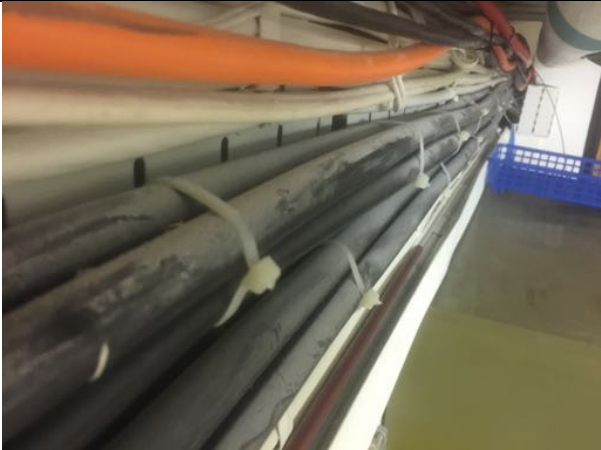
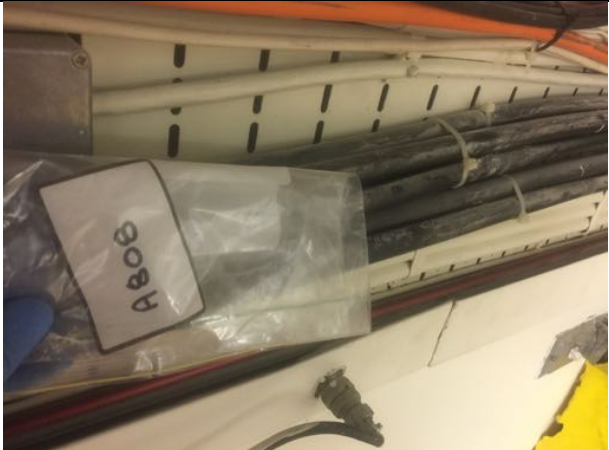
Sample Number				A808		
Date of Sampling				6/3/17		
Location of Sampling				Dust & debris, cable tray		
Sample Result				Amosite Asbestos detected in sampled area		
Sample Risk Score				High Risk- Restrict access, Manage and Remove Under Fully Controlled Conditions		
Asbestos Fibre Type	Surface Treatment	Product Type	Extent of Damage	Likelihood of Disturbance	Risk	Action Rating
2	2	3	3	2	12	A1
Comments & Recommendations				Restrict access Removal or repairs of pipe insulation in room Environmental clean of entire room		
Sample Photos

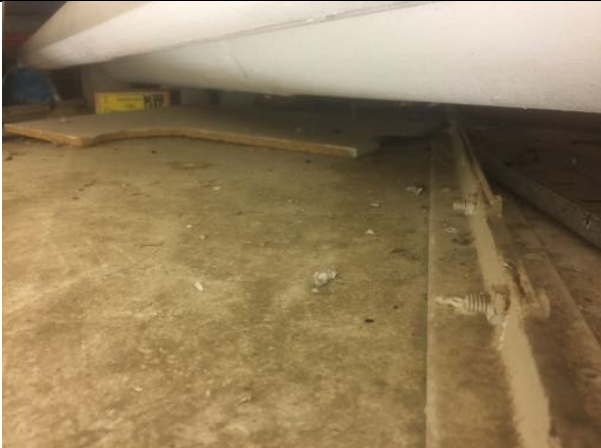
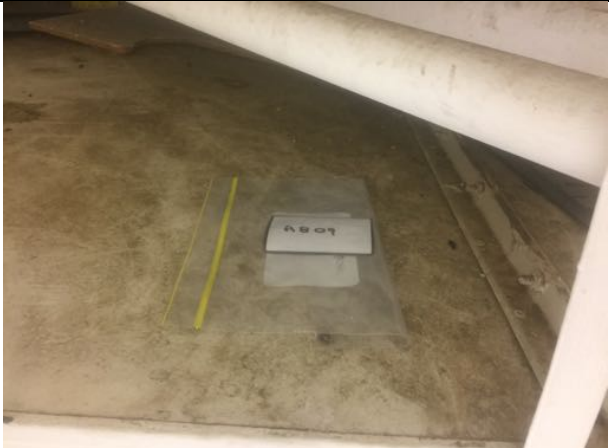
Sample Number				A809		
Date of Sampling				6/3/17		
Location of Sampling				Dust off air venting		
Sample Result				Amosite Asbestos detected in sampled area		
Sample Risk Score				High Risk- Restrict access, Manage and Remove Under Fully Controlled Conditions		
Asbestos Fibre Type	Surface Treatment	Product Type	Extent of Damage	Likelihood of Disturbance	Risk	Action Rating
2	2	3	3	2	12	A1
Comments & Recommendations				Restrict access Removal or repairs of pipe insulation in room Environmental clean of entire room		
Sample Photos

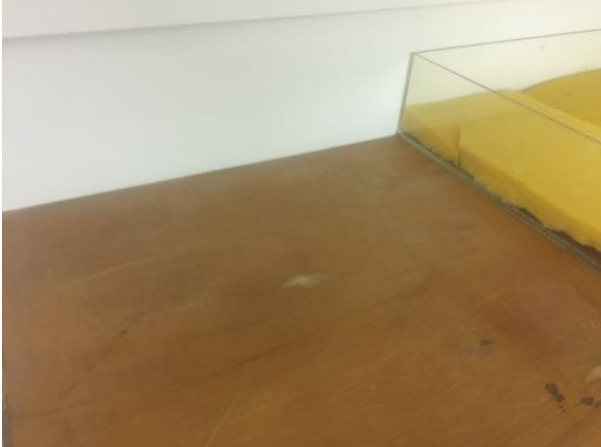
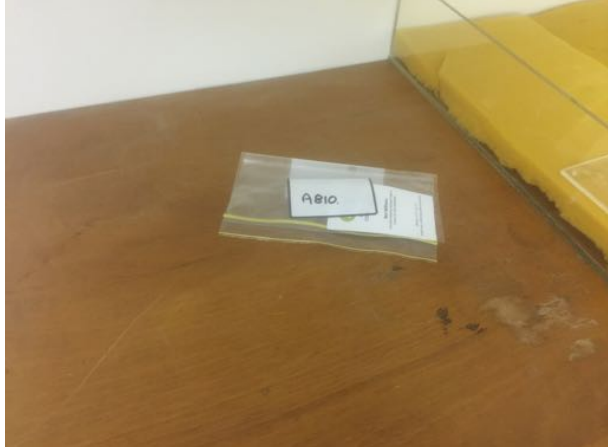
Sample Number				A810			
Date of Sampling				6/3/17			
Location of Sampling				Dust off wooden cupboard			
Sample Result				No Asbestos detected in sampled area			
Sample Risk Score				-			
Asbestos Fibre Type	Surface Treatment	Product Type	Extent of Damage	Likelihood of Disturbance	Risk	Action Rating	
-	-	-	-	-	-	-	
Comments & Recommendations				Due to other samples restrict access Removal or repairs of pipe insulation in room Environmental clean of entire room			
Sample Photos

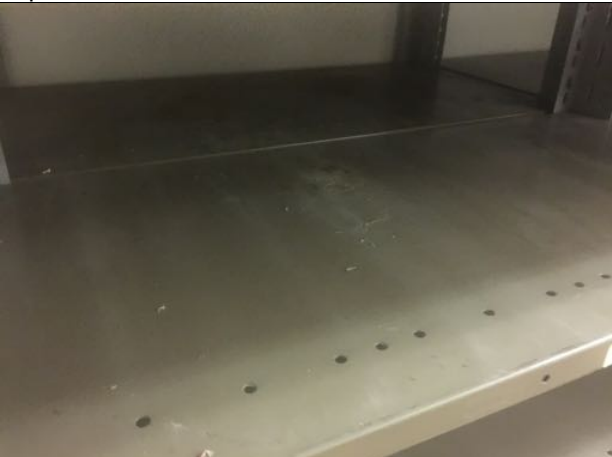
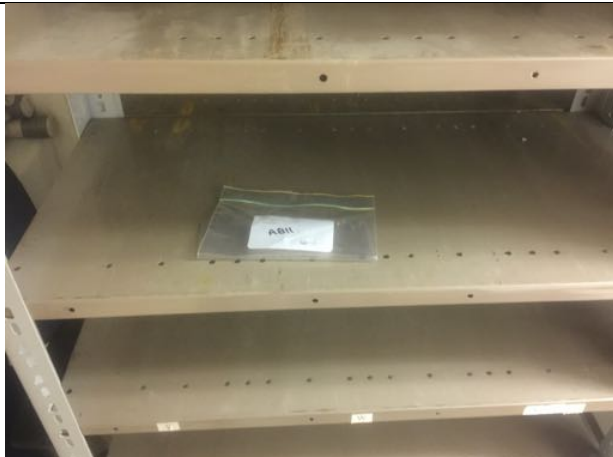
Sample Number				A811			
Date of Sampling				6/3/17			
Location of Sampling				Dust off green shelving			
Sample Result				No Asbestos detected in sampled area			
Sample Risk Score				-			
Asbestos Fibre Type	Surface Treatment	Product Type	Extent of Damage	Likelihood of Disturbance	Risk	Action Rating	
-	-	-	-	-	-	-	
Comments & Recommendations				Due to other samples restrict access Removal or repairs of pipe insulation in room Environmental clean of entire room			
Sample Photos

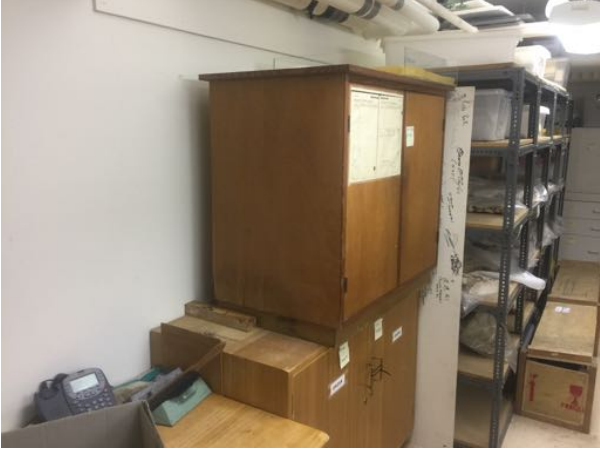
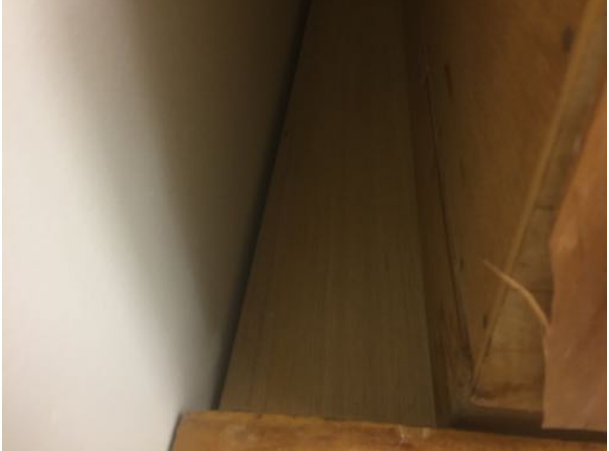
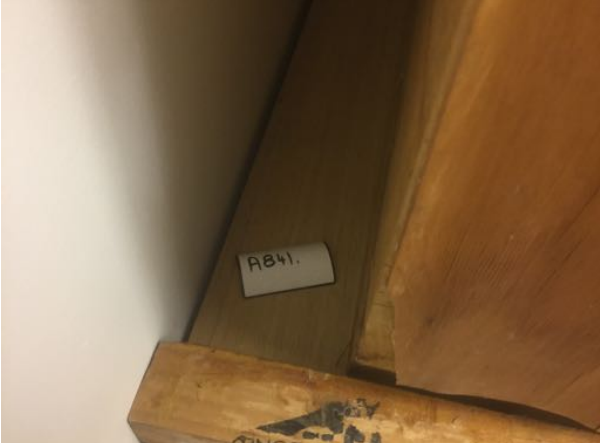
Sample Number				A841		
Date of Sampling				9 th March 2017		
Location of Sampling				Room B4a dust behind cupboard "Gagan"		
Sample Result				Amosite Asbestos detected in sampled area		
Sample Risk Score				High Risk- Restrict access, Manage and Remove Under Fully Controlled Conditions		
Asbestos Fibre Type	Surface Treatment	Product Type	Extent of Damage	Likelihood of Disturbance	Risk	Action Rating
2	2	3	3	2	12	A1
Comments & Recommendations				Restrict access Removal or repairs of pipe insulation in room Environmental clean of entire room Refer to report 06032017-01		
Sample Photos

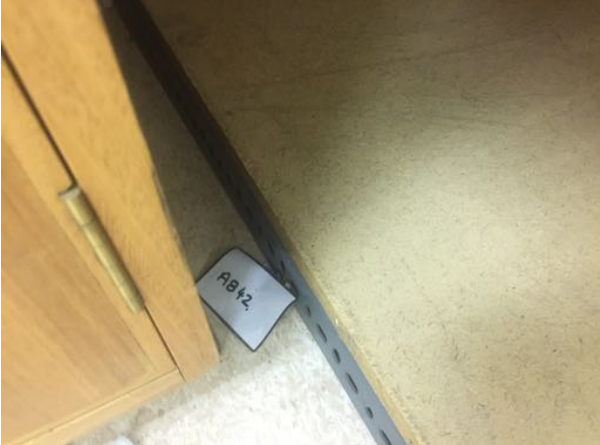
Sample Number				A840		
Date of Sampling				9 th March 2017		
Location of Sampling				Room B4a dust on floor between cupboard & shelves		
Sample Result				Amosite Asbestos detected in sampled area		
Sample Risk Score				High Risk- Restrict access, Manage and Remove Under Fully Controlled Conditions		
Asbestos Fibre Type	Surface Treatment	Product Type	Extent of Damage	Likelihood of Disturbance	Risk	Action Rating
2	2	3	3	2	12	A1
Comments & Recommendations				Restrict access Removal or repairs of pipe insulation in room Environmental clean of entire room Refer to report 06032017-01		
Sample Photos

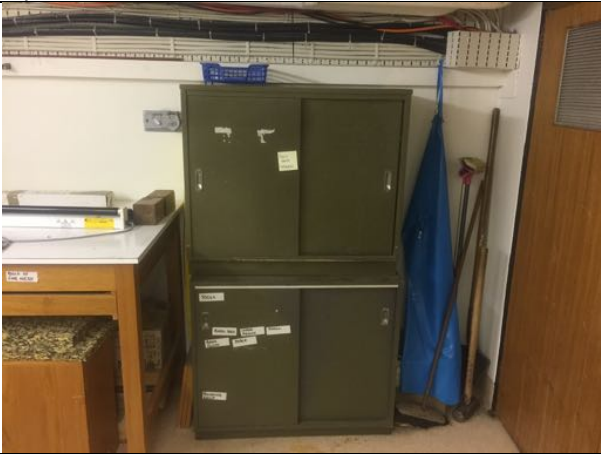
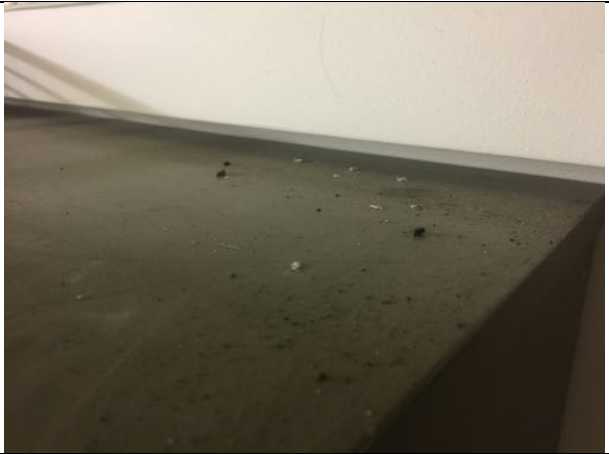
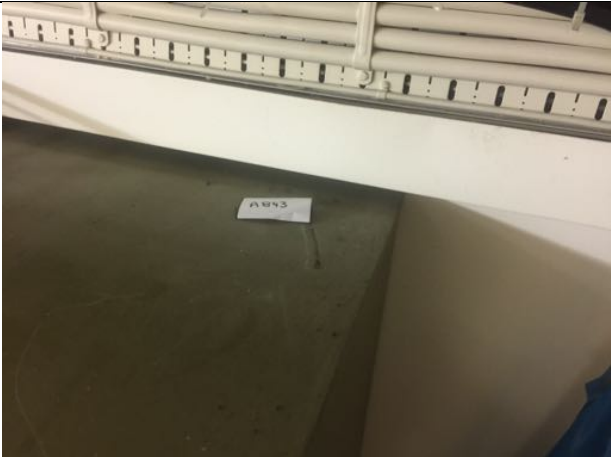
Sample Number				A840		
Date of Sampling				9 th March 2017		
Location of Sampling				Room B4a dust cupboard "Gagan Field Gear"		
Sample Result				Amosite Asbestos detected in sampled area		
Sample Risk Score				High Risk- Restrict access, Manage and Remove Under Fully Controlled Conditions		
Asbestos Fibre Type	Surface Treatment	Product Type	Extent of Damage	Likelihood of Disturbance	Risk	Action Rating
2	2	3	3	2	12	A1
Comments & Recommendations				Restrict access Removal or repairs of pipe insulation in room Environmental clean of entire room Refer to report 06032017-01		
Sample Photos

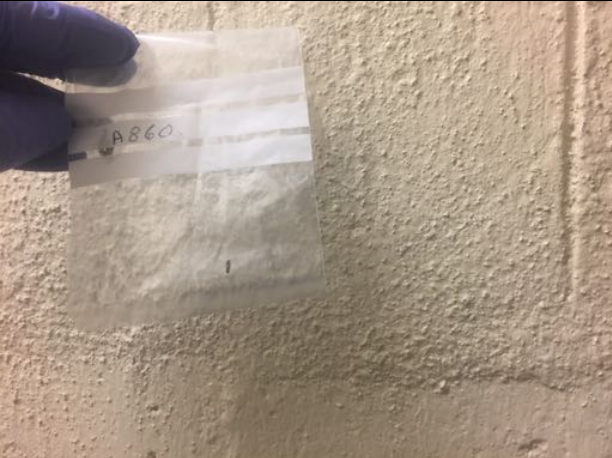
- Corridor
 - Wall penetration rear of B10 into the confined space area was found to have raw ends & visible fibrous debris on the wall & floor below. (Sample A850)

Sample Number		A850				
Date of Sampling		14/3/17				
Location of Sampling		Corridor penetration debris, B10				
Sample Result		No asbestos detected in sampled area				
Sample Risk Score		-				
Asbestos Fibre Type	Surface Treatment	Product Type	Extent of Damage	Likelihood of Disturbance	Risk	Action Rating
-	-	-	-	-	-	-
Comments & Recommendations			<p>Due to other samples restrict access</p> <p>Removal or repairs of pipe insulation.</p> <p>Environmental clean of area</p>			
Sample Photos

- Remove & dispose of the pipe insulation that is penetrating the subfloor wall Ext B10, using glove bag or saturation removal methods.
- Wrap reinforced silver tape to encapsulated all sections of pipe that have exposed ends, damage or where pipe hangers are penetrating the insulation.

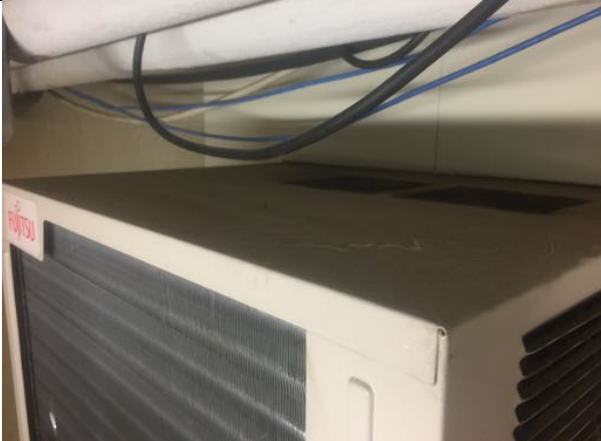
- Damage above AC unit ext B12 exposing raw lagging, visible fibrous debris in dust. (Sample A851)
 - Minor damage & wearing of calico above entry to B3

Sample Number		A851				
Date of Sampling		14/3/17				
Location of Sampling		Corridor dust on AC units, B12				
Sample Result		No asbestos detected in sampled area				
Sample Risk Score		-				
Asbestos Fibre Type	Surface Treatment	Product Type	Extent of Damage	Likelihood of Disturbance	Risk	Action Rating
-	-	-	-	-	-	-
Comments & Recommendations			<p>Due to other samples restrict access</p> <p>Removal or repairs of pipe insulation.</p> <p>Environmental clean of area</p>			
Sample Photos

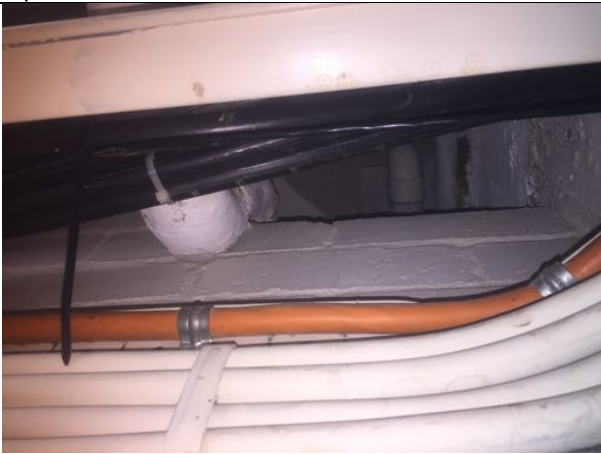
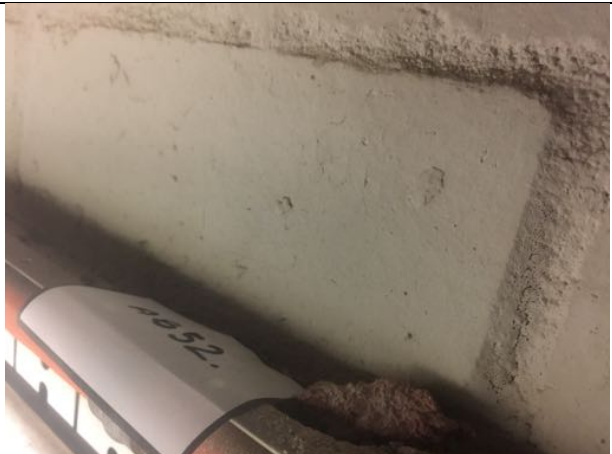
- Unwrapped loose lagging, visible fibrous debris in the cable trays below, above fire extinguisher ext B5 (Sample A852)
- B1
 - 2 pipes in centre of the room running above the air venting, unsealed ends, visible lagging loose above venting & visible fibrous debris in dust in sheeting below. (Sample A853)

Sample Number				A852		
Date of Sampling				14/3/17		
Location of Sampling				Corridor, dust, cable tray, B5		
Sample Result				Amosite asbestos detected		
Sample Risk Score				High Risk- Restrict access, Manage and Remove Under Fully Controlled Conditions		
Asbestos Fibre Type	Surface Treatment	Product Type	Extent of Damage	Likelihood of Disturbance	Risk	Action Rating
2	3	3	3	2	13	A1
Comments & Recommendations				Restrict access Removal or repairs of pipe insulation in room Environmental clean of entire room		
Sample Photos

- Remove & Dispose of Asbestos pipe insulation that is unwrapped or badly damaged Above fire extinguisher ext B5, using glove bag or saturation removal methods.

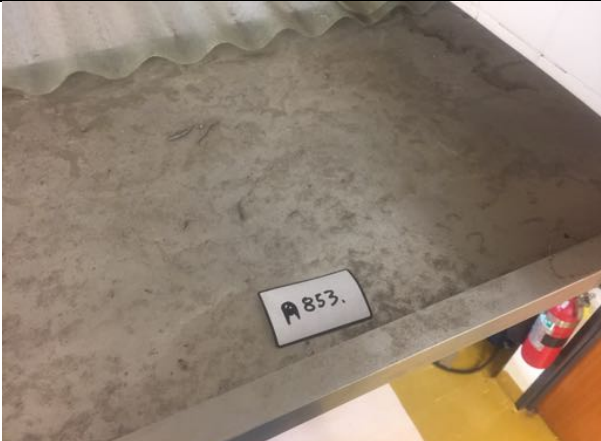
Sample Number				A853		
Date of Sampling				14/3/17		
Location of Sampling				Room B1, dust below double pipes		
Sample Result				Amosite asbestos detected		
Sample Risk Score				High Risk- Restrict access, Manage and Remove Under Fully Controlled Conditions		
Asbestos Fibre Type	Surface Treatment	Product Type	Extent of Damage	Likelihood of Disturbance	Risk	Action Rating
2	3	3	3	2	13	A1
Comments & Recommendations				Restrict access Removal or repairs of pipe insulation. Environmental clean of area		
Sample Photos

- Remove & Dispose of Asbestos pipe insulation that is unwrapped & badly damaged above the central air venting system, using glove bag or saturation removal methods.

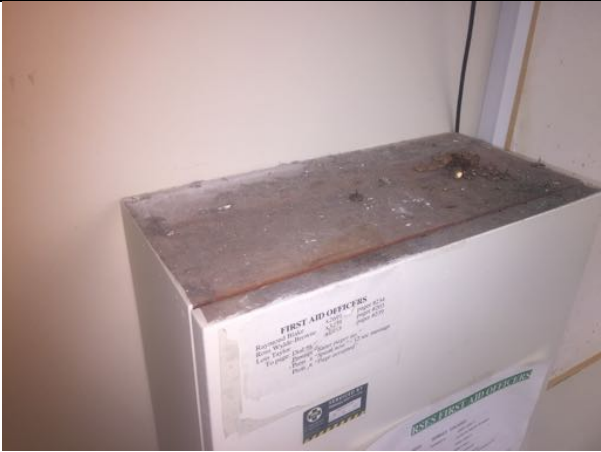
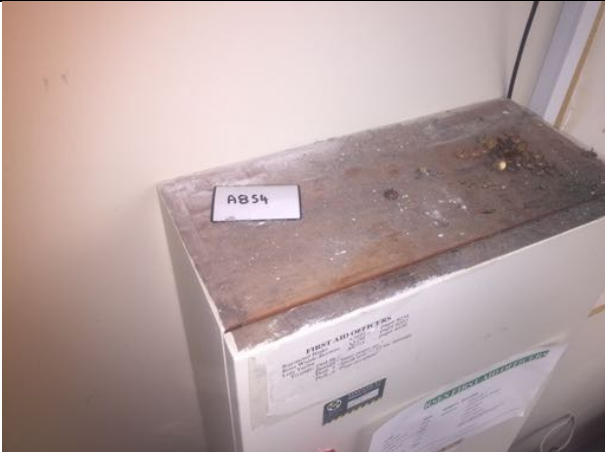
- Pipes entering B1/1 unsealed ends, visible lagging loose above venting & visible fibrous debris in dust in sheeting below. (Sample A854)
 - 3 pipes running along wall B5, unsealed ends on pipe hangers, dust below on CPU was sampled. (Sample A855)

Sample Number				A854		
Date of Sampling				14/3/17		
Location of Sampling				Room B1, dust, First Aid Cabinet		
Sample Result				Amosite asbestos detected		
Sample Risk Score				High Risk- Restrict access, Manage and Remove Under Fully Controlled Conditions		
Asbestos Fibre Type	Surface Treatment	Product Type	Extent of Damage	Likelihood of Disturbance	Risk	Action Rating
2	3	3	3	2	13	A1
Comments & Recommendations				Restrict access Removal or repairs of pipe insulation. Environmental clean of area		
Sample Photos

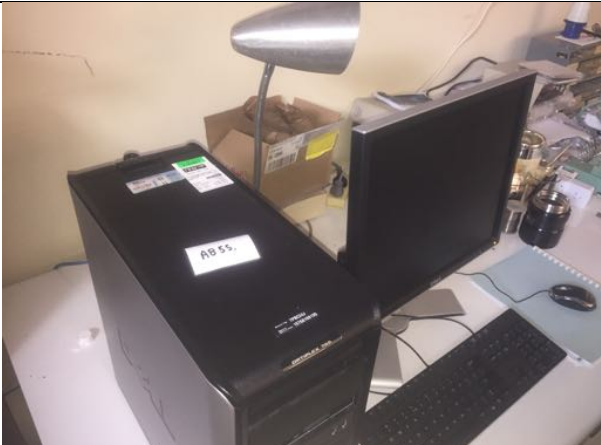
Sample Number				A855		
Date of Sampling				14/3/17		
Location of Sampling				Room B1, dust off CPU 7PBC24J		
Sample Result				No asbestos detected in sampled area		
Sample Risk Score				-		
Asbestos Fibre Type	Surface Treatment	Product Type	Extent of Damage	Likelihood of Disturbance	Risk	Action Rating
-	-	-	-	-	-	-
Comments & Recommendations				Due to other samples restrict access Removal or repairs of pipe insulation. Environmental clean of area		
Sample Photos

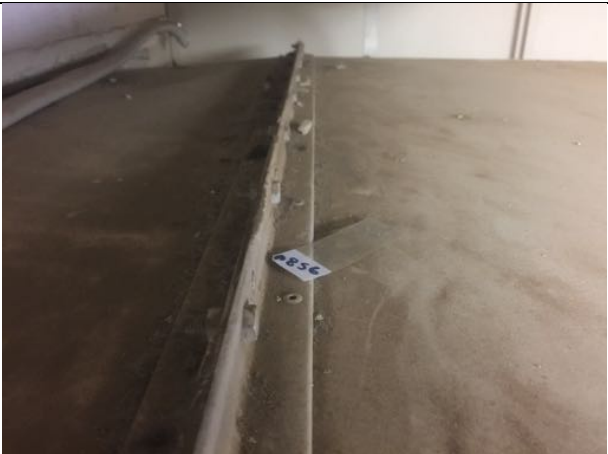
- B2
 - Entry door to corridor, poor section of lagging above the air venting exposing raw lagging, visible fibrous debris in dust on venting. (Sample A856)

Sample Number				A856		
Date of Sampling				15/3/17		
Location of Sampling				B2 Dust above door		
Sample Result				Amosite asbestos detected		
Sample Risk Score				High Risk- Restrict access, Manage and Remove Under Fully Controlled Conditions		
Asbestos Fibre Type	Surface Treatment	Product Type	Extent of Damage	Likelihood of Disturbance	Risk	Action Rating
2	3	3	3	2	13	A1
Comments & Recommendations				Restrict access Removal or repairs of pipe insulation. Environmental clean of area		
Sample Photos

- Remove & Dispose of Asbestos pipe insulation that is unwrapped & badly damaged above the air venting system corridor access door, using glove bag or saturation removal methods.

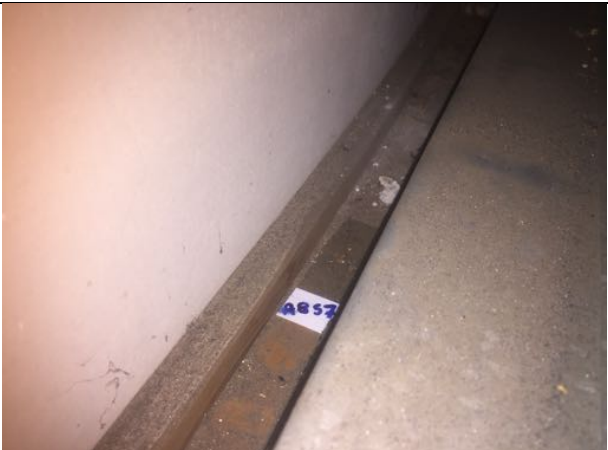
- Raw end of insulation left unsealed above compressor unit.
 - Pipe lagging above doors was found to have an exposed joint with visible debris in the cable tray below (Sample A857)

Sample Number				A857		
Date of Sampling				15/3/17		
Location of Sampling				B3 cable tray above door		
Sample Result				Amosite asbestos detected		
Sample Risk Score				High Risk- Restrict access, Manage and Remove Under Fully Controlled Conditions		
Asbestos Fibre Type	Surface Treatment	Product Type	Extent of Damage	Likelihood of Disturbance	Risk	Action Rating
2	3	3	3	2	13	A1
Comments & Recommendations				Restrict access Removal or repairs of pipe insulation. Environmental clean of area		
Sample Photos

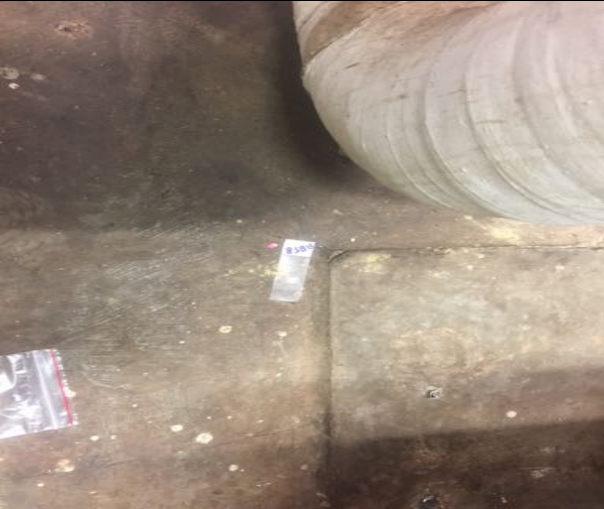
- Dust on the floor below the Air Compressor unit was sampled (Sample A858)
- B10
 - Poor section of pipe lagging in rear corner, visible unsealed wrapping on pipe lagging & unsealed ends. Access to this lagging is restricted.

Sample Number				A858		
Date of Sampling				15/3/17		
Location of Sampling				B3 dust below compressed air unit		
Sample Result				Amosite asbestos detected		
Sample Risk Score				High Risk- Restrict access, Manage and Remove Under Fully Controlled Conditions		
Asbestos Fibre Type	Surface Treatment	Product Type	Extent of Damage	Likelihood of Disturbance	Risk	Action Rating
2	3	3	3	2	13	A1
Comments & Recommendations				Restrict access Removal or repairs of pipe insulation. Environmental clean of area		
Sample Photos

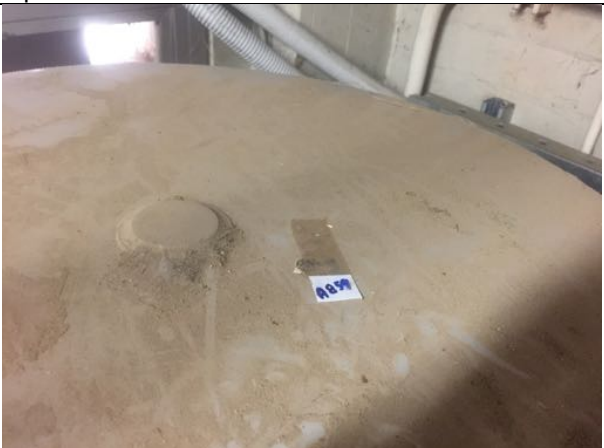
Sample Number				A859		
Date of Sampling				15/3/17		
Location of Sampling				B10 Dust on water tank		
Sample Result				No Asbestos detected in sampled area		
Sample Risk Score				-		
Asbestos Fibre Type	Surface Treatment	Product Type	Extent of Damage	Likelihood of Disturbance	Risk	Action Rating
-	-	-	-	-	-	-
Comments & Recommendations				Due to other samples restrict access Removal or repairs of pipe insulation. Environmental clean of area		
Sample Photos

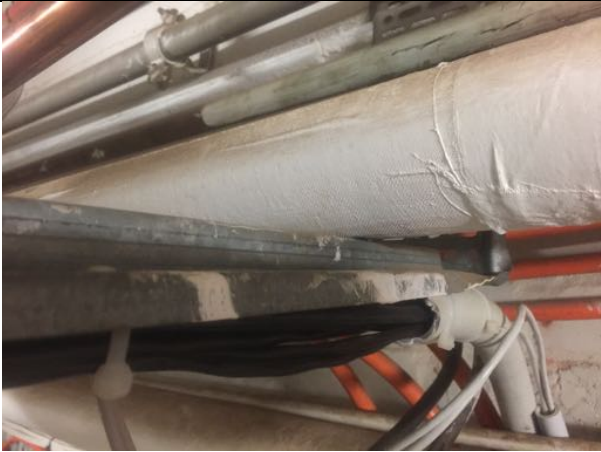
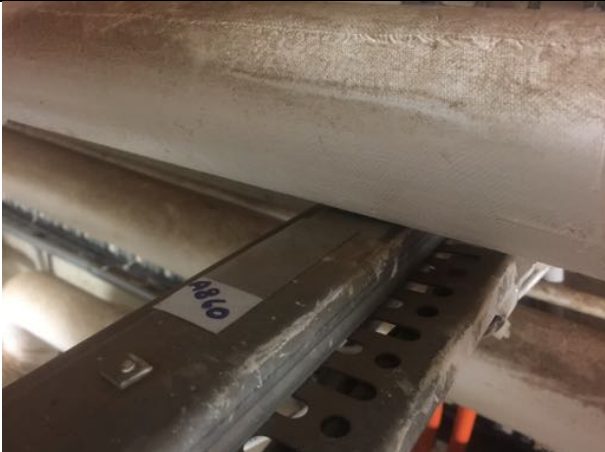
- Small areas of damage exposing raw lagging, these were circled during the inspection.
 - Dust on the water tank was sampled (Sample A859)
 - A section of pipe lagging was found to be resting on a cable tray, a small section of raw lagging was exposed. (Sample A860)

Sample Number				A860		
Date of Sampling				15/3/17		
Location of Sampling				B10 dust on cable trays		
Sample Result				Amosite asbestos detected		
Sample Risk Score				High Risk- Restrict access, Manage and Remove Under Fully Controlled Conditions		
Asbestos Fibre Type	Surface Treatment	Product Type	Extent of Damage	Likelihood of Disturbance	Risk	Action Rating
2	3	3	3	2	13	A1
Comments & Recommendations				Restrict access Removal or repairs of pipe insulation. Environmental clean of area		
Sample Photos
