PROJECT DETAILS

JOB NUMBER	KEF462	INSPECTION DATE	17/07/2017	
CLIENT	AGH Demolition & Asbestos Removal	REPORT DATE	17/07/2017	
CONTACT NAME	Brett Gibson	CONTACT NUMBER	+61402882305	
SITE ADDRESS	Jaeger 1 Building, Australian National University (ANU) - Mills Road, Acton, ACT 2601			
SCOPE OF WORKS	Removal of friable asbestos pipe lagging to stage two area in the basement.			
ASBESTOS CONTRACTOR	AGH Demolition & Asbestos Removal	SUPERVISOR	John coulter	
ASBESTOS ASSESOR	Ged Keane	LICENCE NUMBER	LAA001142	
LEGISLATION	A thorough visual inspection of the enclosure was conducted followed by a smoke test as per section 5.2 Testing an enclosure of the Code of Practice How to Safely Remove Asbestos (2011),

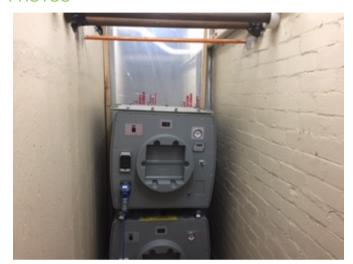
Negative pressure unit

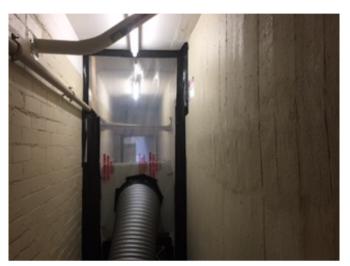
Negative pressure units end of enclosure
