Friable Asbestos Enclosure Check Report

JOB NUMBER	KEF462	INSPECTION DATE	13/06/2017	
CLIENT	AGH Demolition & Asbestos Removal	REPORT DATE	13/06/2017	
CONTACT NAME	Brett Gibson	CONTACT NUMBER	+61402882305	
SITE ADDRESS	Jaeger 1 Building, Australian National University (ANU) - Mills Road, Acton, ACT 2601			
SCOPE OF WORKS	Encapsulation and sealing of stage one friable asbestos removal area.			
ASBESTOS CONTRACTOR	AGH Demolition & Asbestos Removal	SUPERVISOR	John coulter	
ASBESTOS ASSESOR	Ged Keane	LICENCE NUMBER	LAA001142	
LEGISLATION	A thorough visual inspection of the enclosure was conducted followed by a smoke test as per section 5.2 Testing an enclosure of the Code of Practice How to Safely Remove Asbestos (2011),

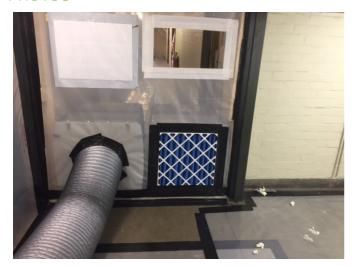
Negative pressure unit

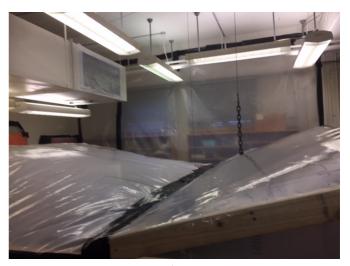
Encapsulation of laser equipment

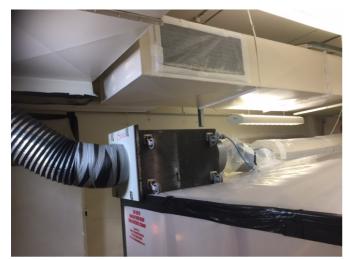
Negative pressure unit to draw in cool air for laser equipment

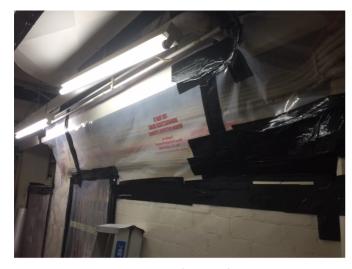
Encapsulation of internal fittings

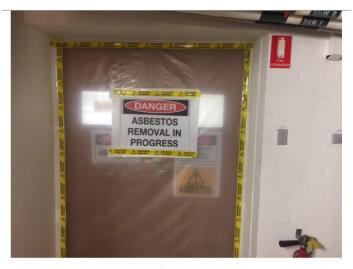
Encapsulation of access agrees points
