Heritage Management Plan

DRILL HALL GALLERY

Australian Capital Territory

August 2010

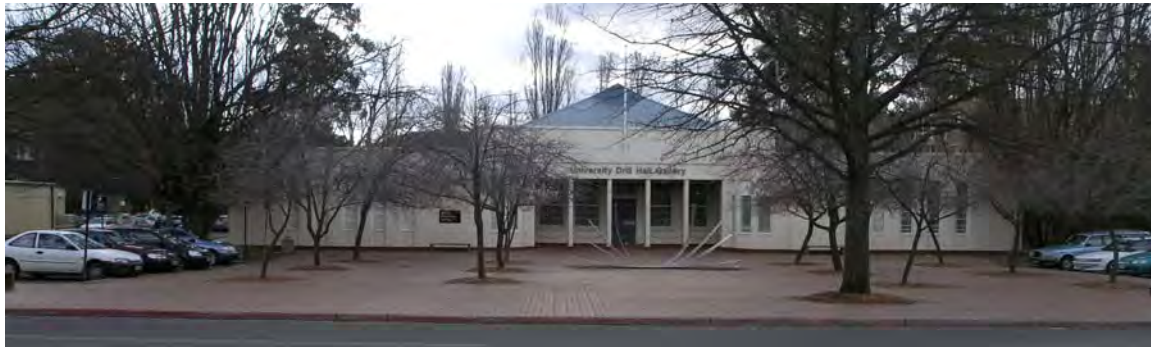
Drill Hall Gallery – front view

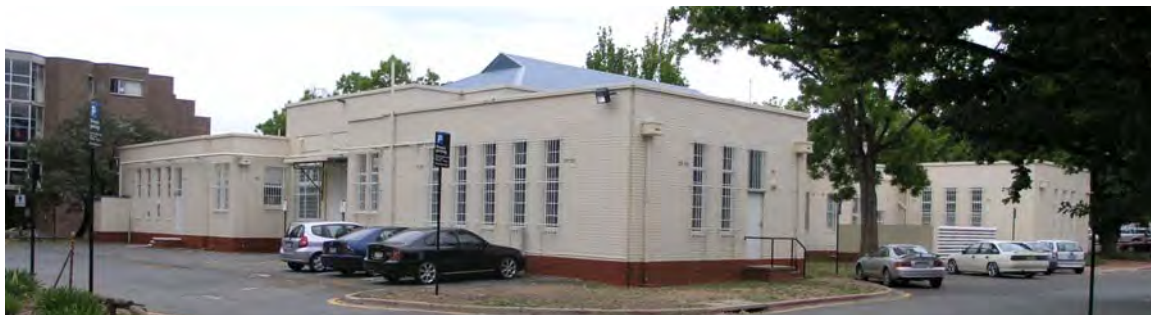
Drill Hall Gallery – rear view

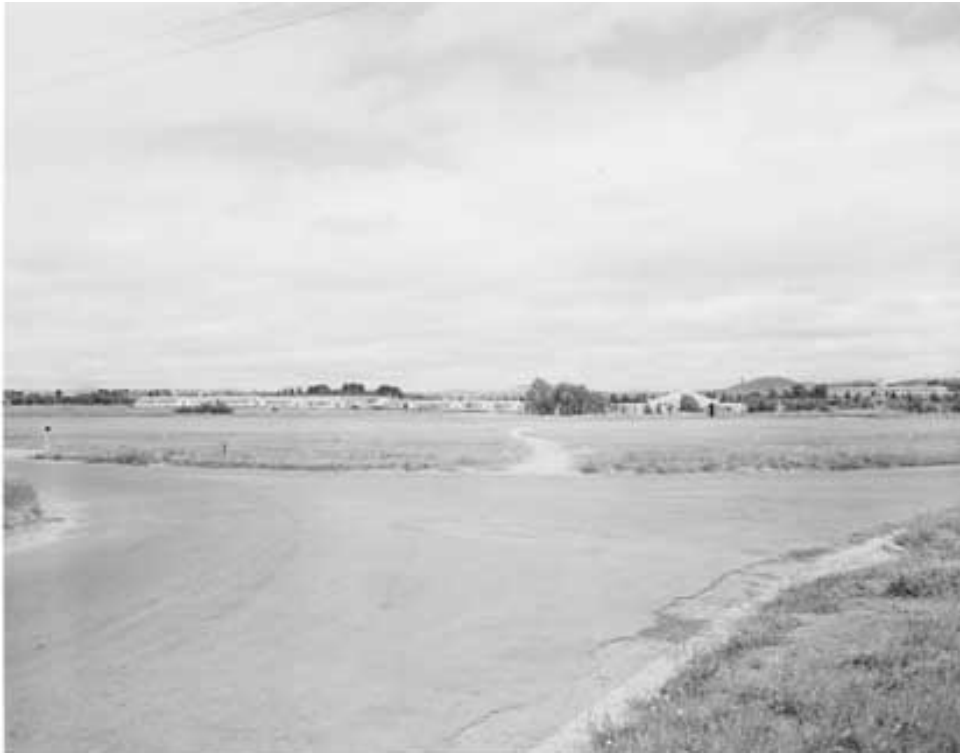
Figure 3.1: The landscape surrounding the Drill Hall Gallery (centre right) was originally sparse with few trees (NAA A7973, INT44)

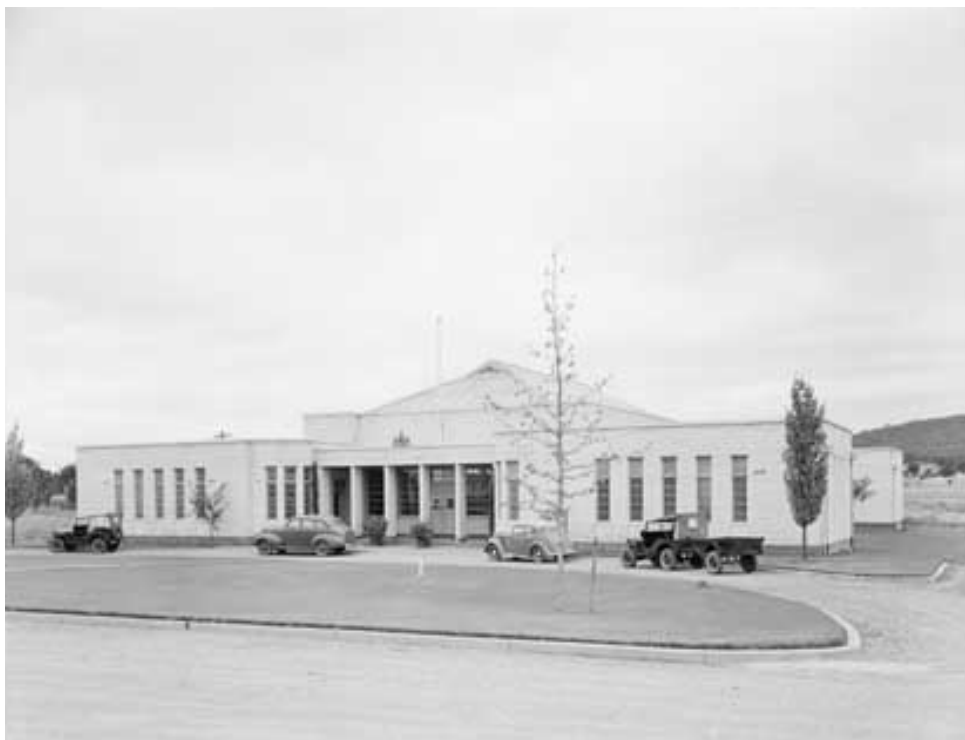
Figure 3.2: Drill Hall Gallery, 1951 (NAA A7973, INT85)

Two mature *quercus pedunculata fastigiata* (Pedunculate oaks) flank the front entrance of the Drill Hall, both of which can be seen in Figure 3.2 (likely planted in the early 1950s). In the 1980s a group of *pyrus pashia* were also planted in the terraced area in front of the Gallery as part of the refurbishment works to convert the building into exhibition space. All of the trees mentioned above are significant for their heritage value, and are also considered to be of high or exceptional status for tree species on the ANU campus.

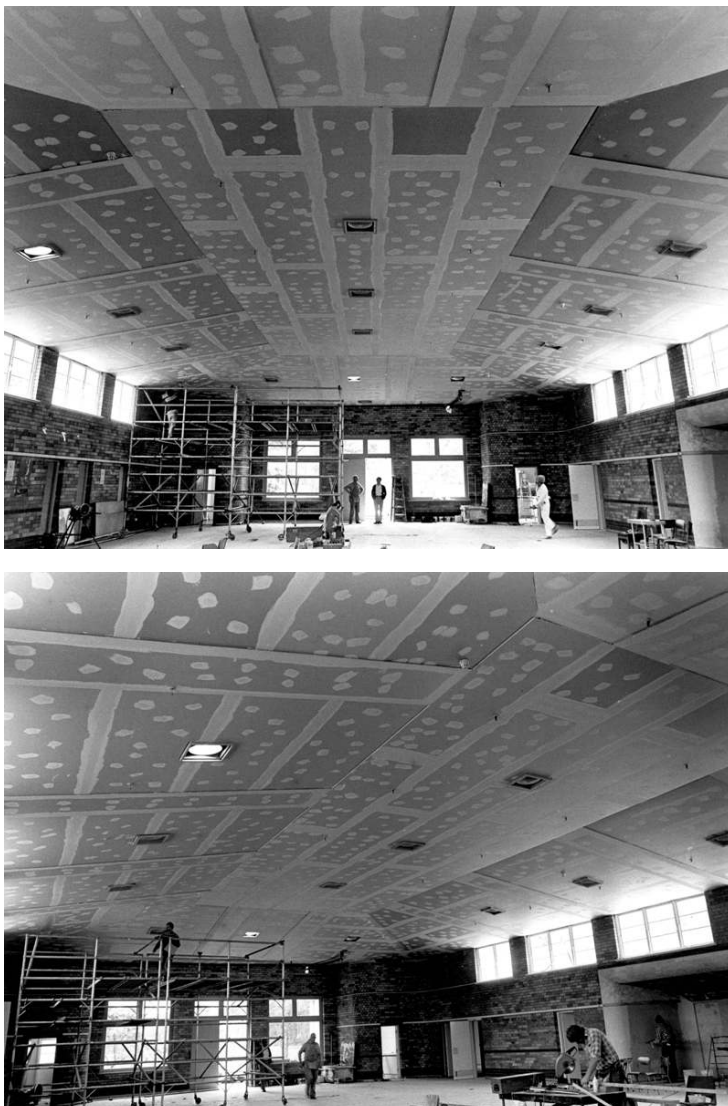
Figure 3.5: False walls and ceilings were added to the building when it was converted into an art gallery in the mid-1980s (Sept 1984, ANU Archives).

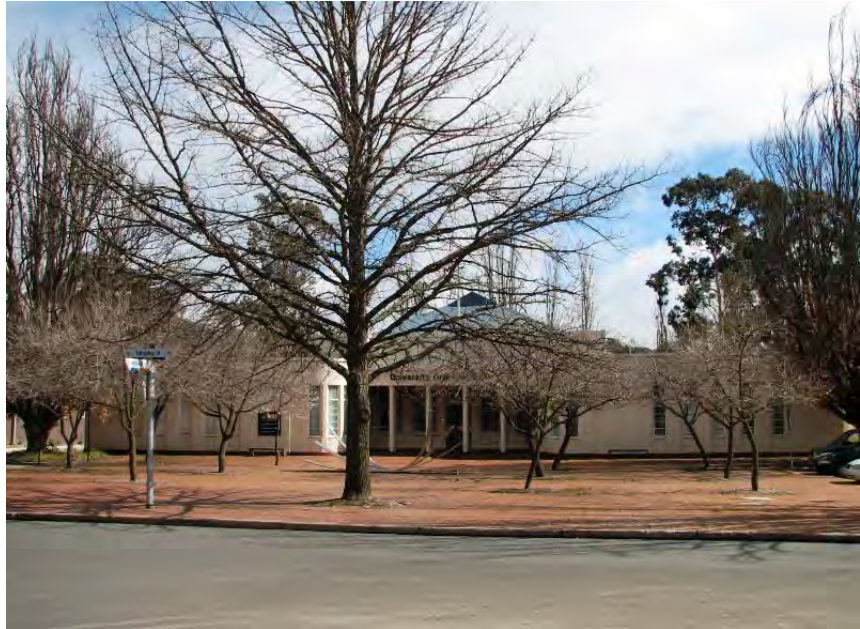
Figure 4.5: View southwest of the front of the Drill Hall Gallery, including notable trees and artwork by Ken Unsworth, *Untitled*

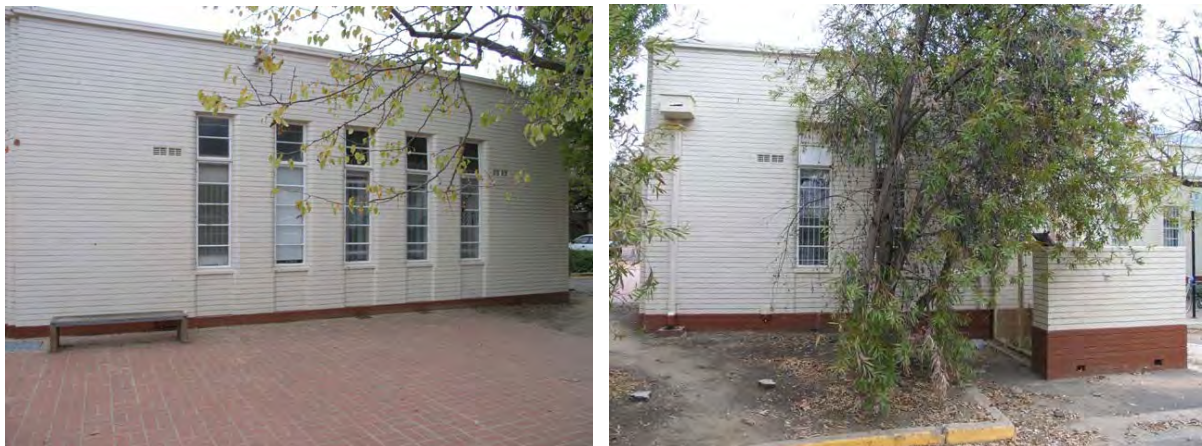
Figure 4.6: Windows and air-con. unit enclosure on the southeast corner

The **southeast corner** originally housed the main offices of the Drill Hall. The windows of this area are long and narrow five-pane casement examples with a double pane transom window above. These windows are set in metal frames; the three easterly examples showcase the original iron grills. The other two windows on this side have iron bars.

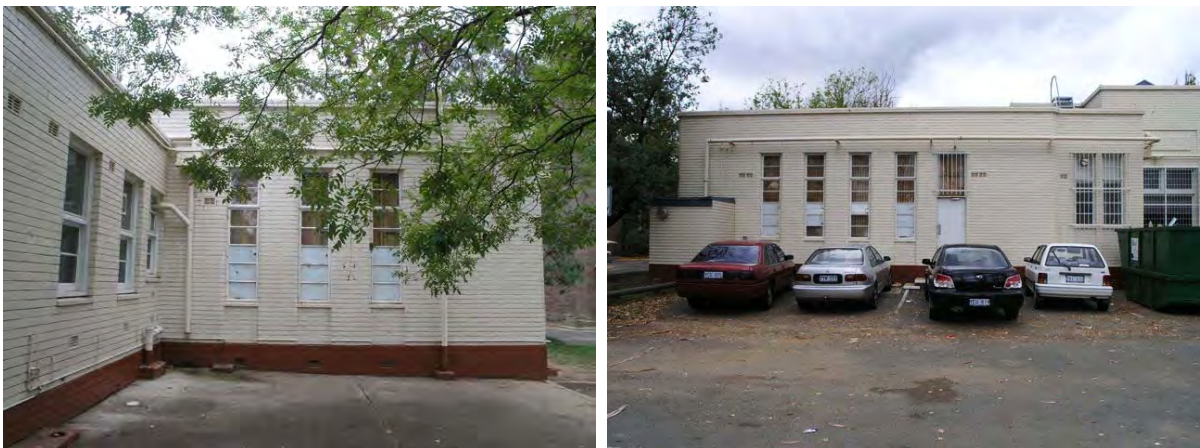
Figure 4.7: Windows and downpipes of the northeast corner

The **northeast corner** originally housed the Men's Institute. This section displays the same pattern of triple casement with transom, set in steel frames. Many original elements have been retained in this area, such as the windows, rain-heads and downpipes along the eastern wall; round downpipes on the eastern side replace the original. A brick enclosure for an air-conditioning unit has been erected in the northeast corner, similar to that found on the opposite side of the building.

A single door replaces the western-most casement window, though is no longer used. Set adjacent to the corner of the building are two shorter four-pane casement windows with transoms above. All the larger narrow windows showcase the steel frames with rounded edges and brick sills.

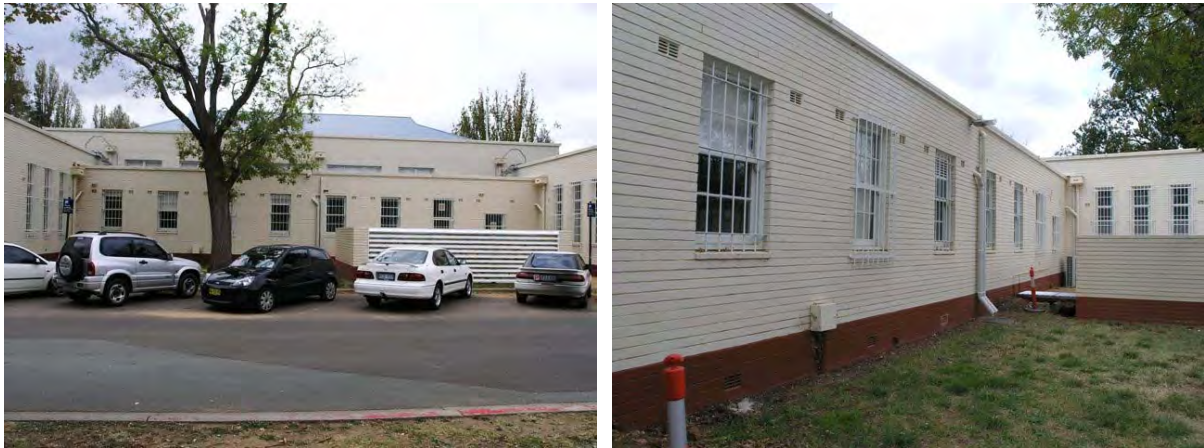
Figure 4.8: The window grilles and air cond. unit enclosure of the west side of the building

The **western side** of the building mirrors its counterpart, though no door is evident. Eight windows similar to those of the east side punctuate the wall at regular intervals, though one (closest to the front) has been replaced with a single-pane fixed window that is shorter than the others. The clerestory windows are identical, and there are only two rain-heads and downpipes on this side.

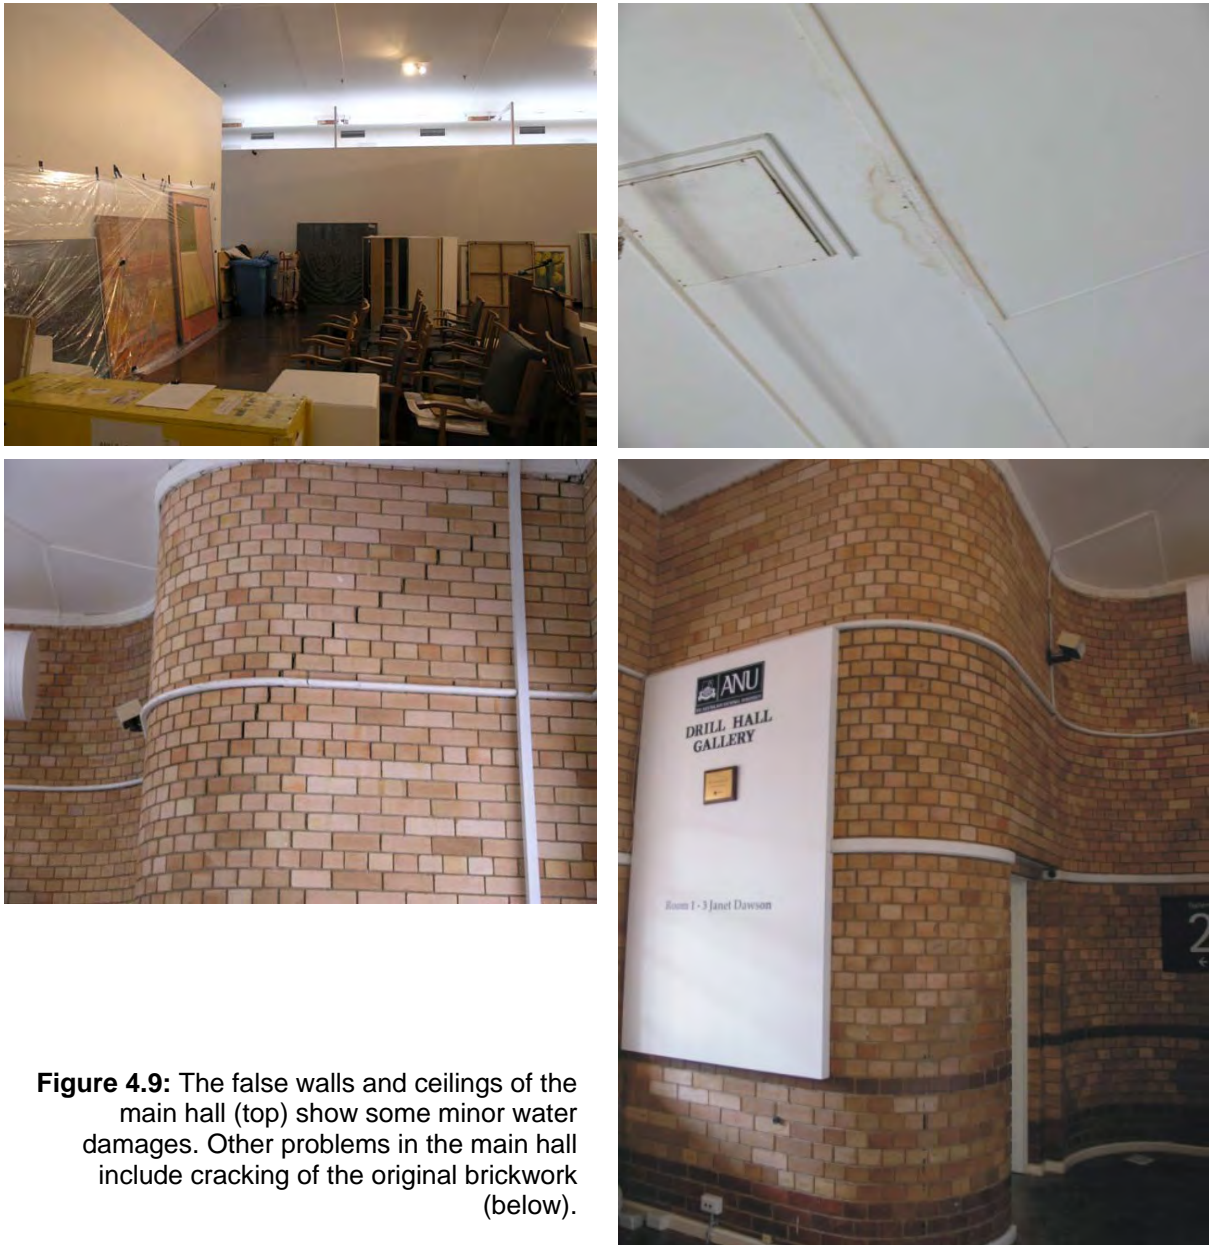
Figure 4.9: The false walls and ceilings of the main hall (top) show some minor water damages. Other problems in the main hall include cracking of the original brickwork (below).

The brickwork is fair-faced and has raked joints. There are two wooden string courses (“picture rails”) that are located at intervals about one-third the height of the internal walls. Modern air-conditioning ductwork has been installed along the upper levels of the hall. These have a direct impact on the amount of light permitted through the clerestory windows. It is important to have an efficient climate-control system for the gallery, but these do have an impact on the amount of light in the hall.

There is evidence of ongoing water damage to the cornices in the main hall and floor around the door leading into the tea-room.

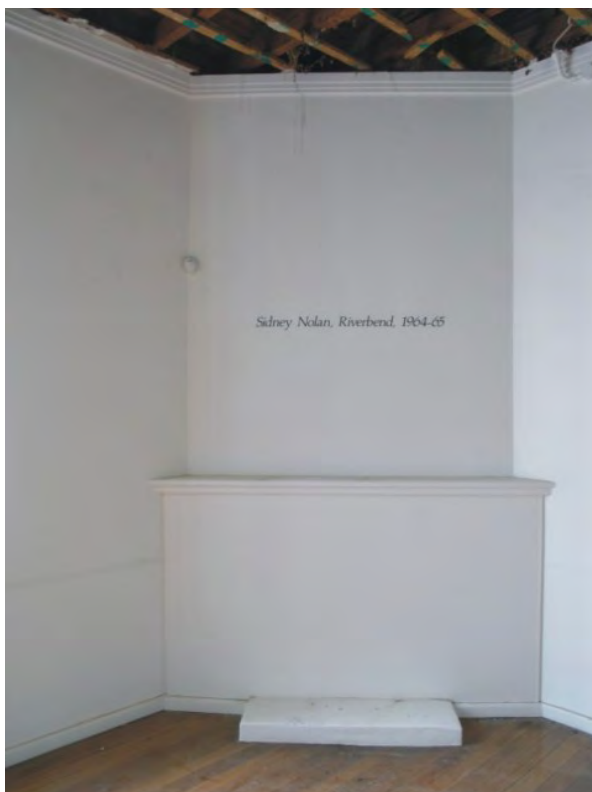
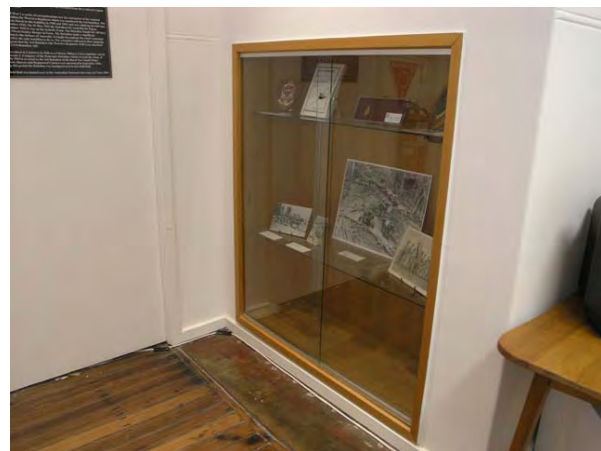
Figure 4.10: The kitchen range (above) has been converted into a memorial display for the 3rd Battalion, The Werriwa Regiment and 3 RNSWR.

The general form of the fireplace in the Sergeants' Mess (left) has been retained, and converted into an attractive display space.

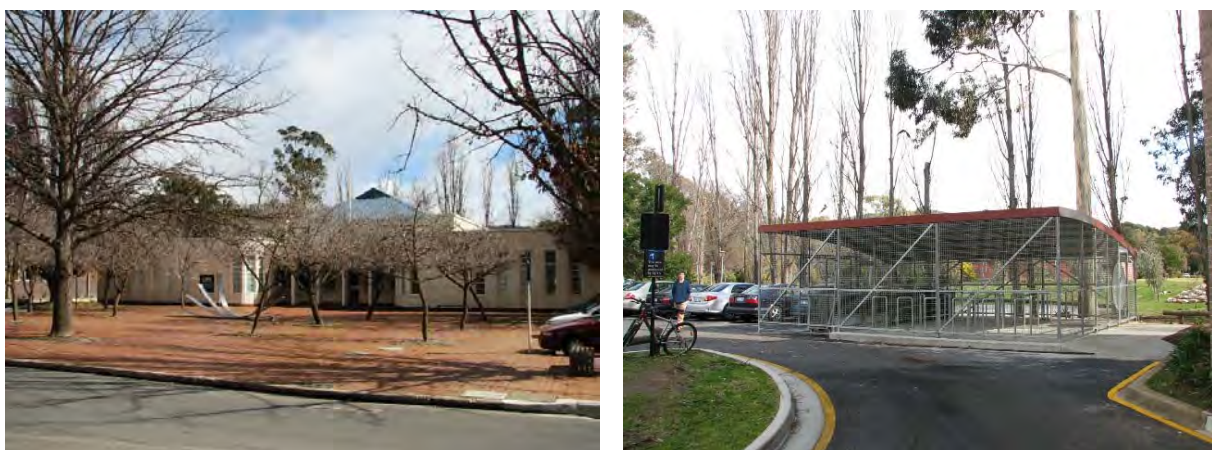
Figure 4.11: Many original tree species have been protected around the Drill Hall Gallery, including the small group of *Pyrus pashia* flanking the entrance (left). A large bike shelter has recently been constructed to the rear of the Drill Hall, beneath the shadow of poplars along Sullivans Creek (right)

A number of significant white poplar trees have been retained and protected to the rear of Drill Hall and neighbouring Toad Hall. These appear to pre-date the construction of the student residence and are considered to have high significance. These species, as with the street oaks, contribute heavily to the views of the two buildings and must be maintained. The area to the rear of the Drill Hall and Toad Hall buildings, along Sullivans Creek, is part of an important biodiversity corridor for the ANU campus. It is vital that any future works along the Creek ensure protection of these values.

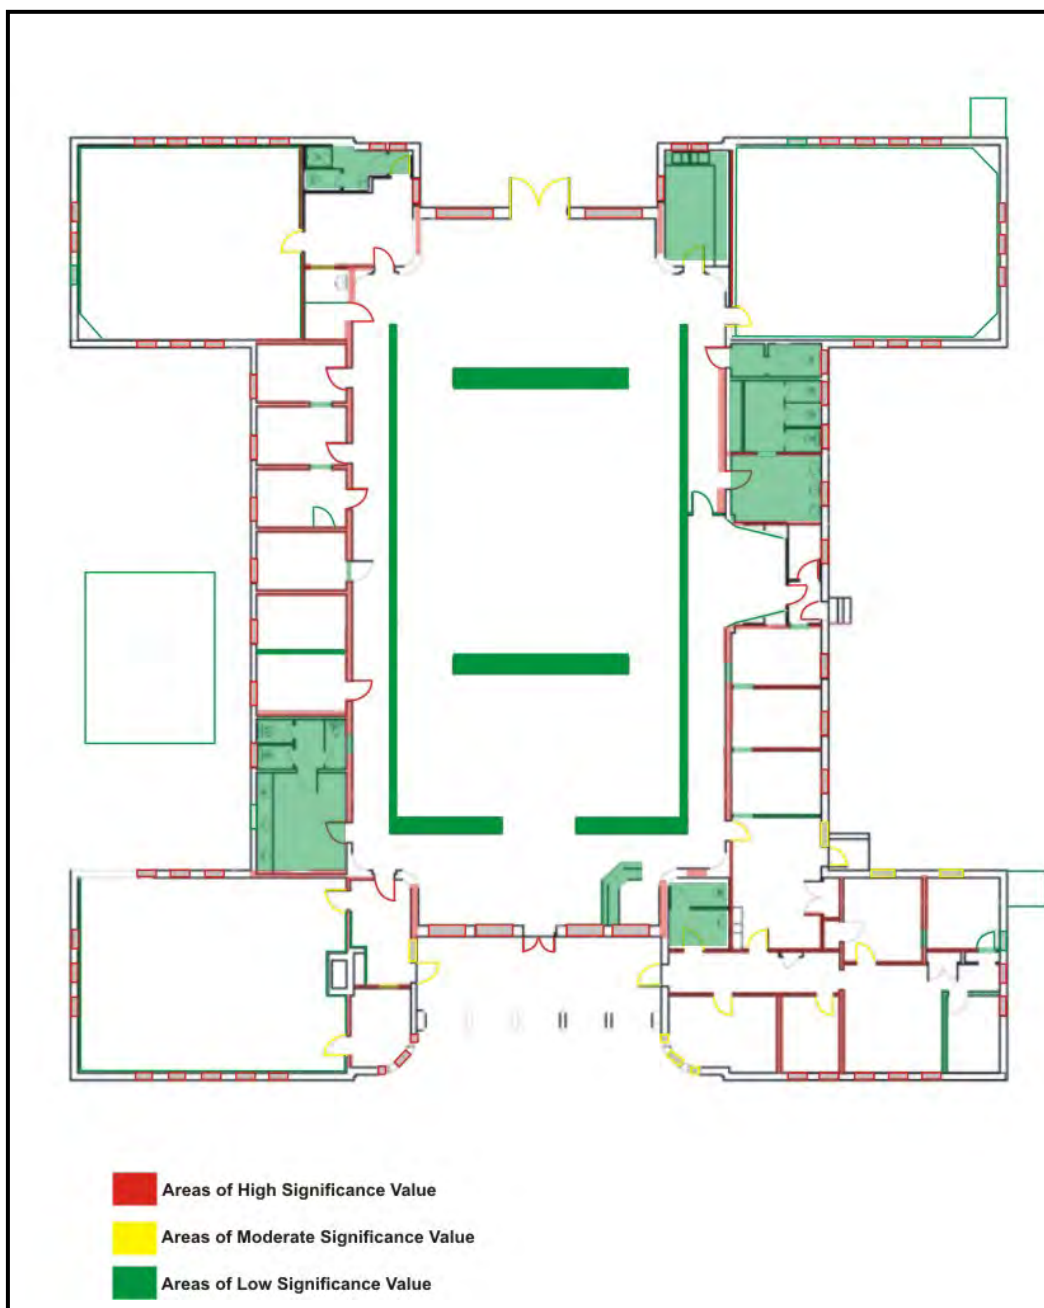
Figure 5.1: Significance values of specific areas of the Drill Hall Gallery

- **High:** Retain and actively conserve. Appropriate treatment for items of high heritage significance would include maintenance, preservation, restoration and reconstruction.
- **Moderate:** The preferred options for items of moderate significance are retention and adaptation for reuse although other options including removal in whole or part may be considered.
- **Low:** The preferred options for items of low significance might include removal or modification to reduce adverse impact.
