## SIDING SPRING OBSERVATORY Heritage Management Plan: Volume 2

Final Inventory  
June 2015

Prepared for  
Australian National University

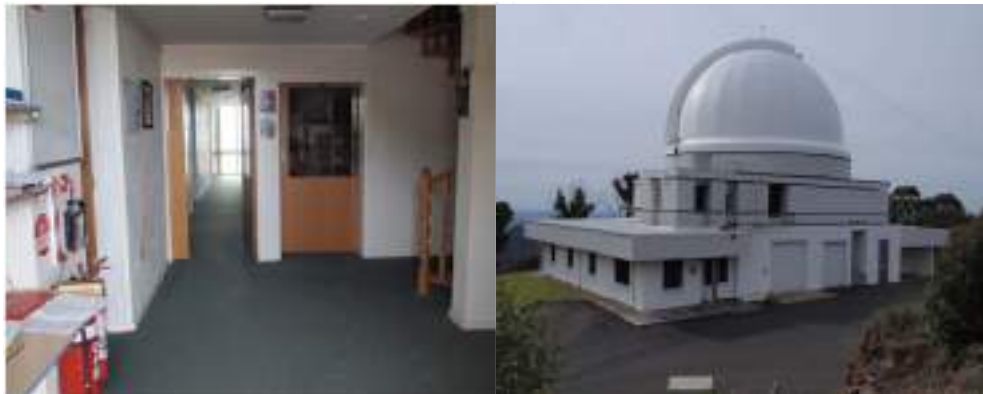
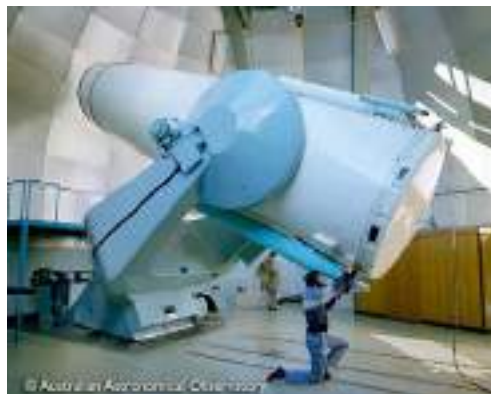
ANU ID Number	<b>N001</b>
HMP Number	<b>001</b>
Type	<b>Astrograph</b>
Ownership	<b>ANU (Building only) AAO owns Scope and all internals of building</b>
Management	<b>AAO</b>
Status	<b>Active</b>
Date constructed/ installed	<b>1972-73</b>
Level of significance	<b>High</b>

Good condition generally although it is understood that an accident with the telescope resulted in some internal damage. The building was unoccupied at the time of the site inspection. Telescope is to be refurbished for use 2015.

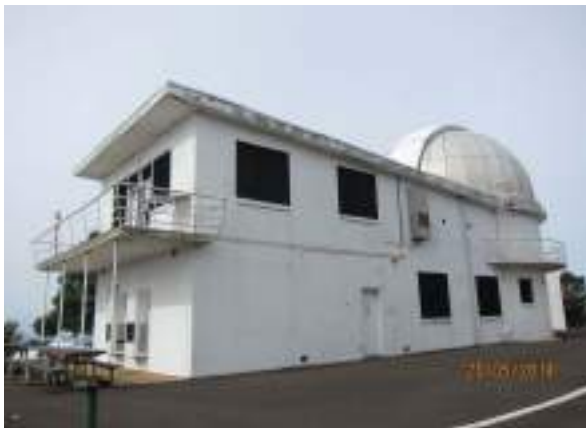
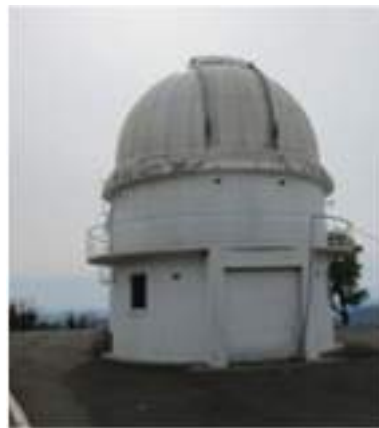
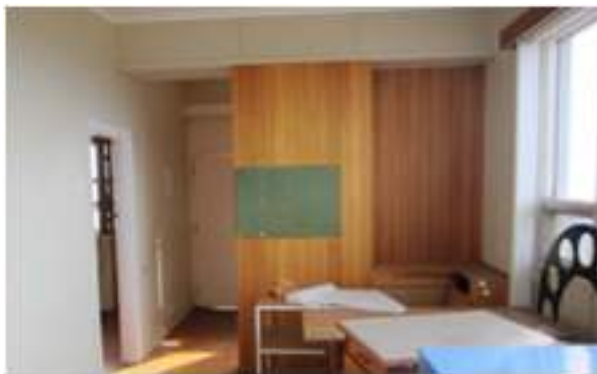
ANU ID Number	<b>N002</b>
HMP Number	<b>002</b>
Type	<b>Telescope</b>
Ownership	<b>ANU</b>
Management	<b>ANU</b>
Status	<b>Redundant [telescope donated to Milroy Observatory in 2009]</b>
Date constructed/ installed	<b>1963-64</b>
Level of significance	<b>High</b>

The building is in fair condition, with only cosmetic damage/deterioration relating to water damage of the external render. Dead mice observed inside suggest some infestation.

The building is no longer used - the telescope itself having been removed. Examples elsewhere on the site suggest that the wooden dome will be prone to deterioration.

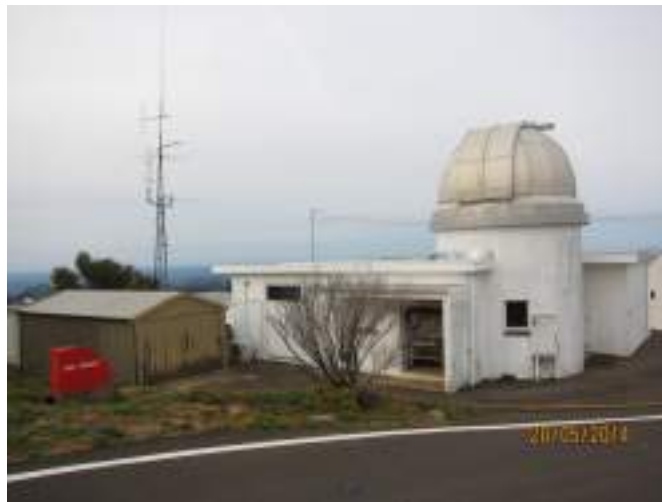
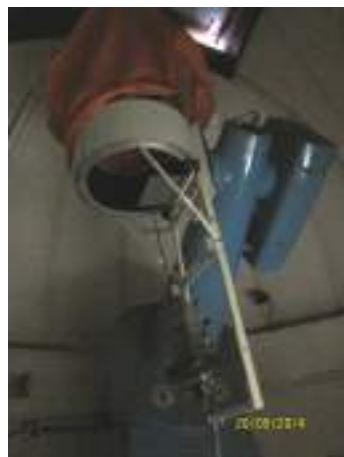
ANU ID Number	<b>N005</b>
HMP Number	<b>005</b>
Type	<b>Telescope</b>
Ownership	<b>ANU</b>
Management	<b>ANU</b>
Status	<b>Redundant (telescope only)</b>
Date constructed/ installed	<b>c1964-65</b>
Level of significance	<b>High</b>

A rendered brick telescope building similar in configuration and construction to 40" (N02) and 24" (N07) telescope buildings. It appears to have been built on a constructed platform which is broken to the north by a small concrete path leading to a hatch. This evidently provides access to a void beneath the structure. The building essentially exists as two ranges aligned north to south, side by side. Both are single storey, except for where a concrete telescope dome structure extends above the southern part of the western range. The telescope chamber, beneath the aluminium sheet dome, has a concrete slab floor over which lies a circular steel platform comprising a 'lift floor'. This could be hydraulically raised by a shaft housed in a steel column in the chamber below which was powered by a mechanism located in the void under the building. A single concrete stair, built in from the external wall, provides access to the telescope chamber and features metal safety barriers at the top to prevent injury relating to the lift mechanism. The telescope dome is redundant, the telescope having been dismantled (with parts apparently used elsewhere in the site) although its equatorial mounting remains together with a variety of related paraphernalia and fittings including original lights and control panels. The ground floor chamber is used for storage and contained several sections of the telescope at the time of survey. To the west and north of this chamber are a series of small rooms (not accessed but identified from plans as including a computer room and dark room). These include one small chamber of unclear purpose which is externally accessed from the west, via a large covered porch, and which at the time of survey contained a rack containing small drawers of small components (screws etc). The remainder of the western range is occupied by a large workshop with a double external door to the west. To the east, a central corridor separates these rooms from a row of offices, each with an east facing window, and a small WC also opens onto it. This corridor is accessed via the building's main entrance – a single door at its southern end.

Some ephemeral deterioration, in the form of peeling paint, is evident in the redundant part of the structure, but otherwise it is in good condition. However, a lack of light made an assessment of the condition of the dome difficult.

The building is currently in use, but only for workshop and administrative functions – the dome is redundant and thus vulnerable to deterioration.

There is a need to archive information on equipment and parts to inform the manufacture of replacements.

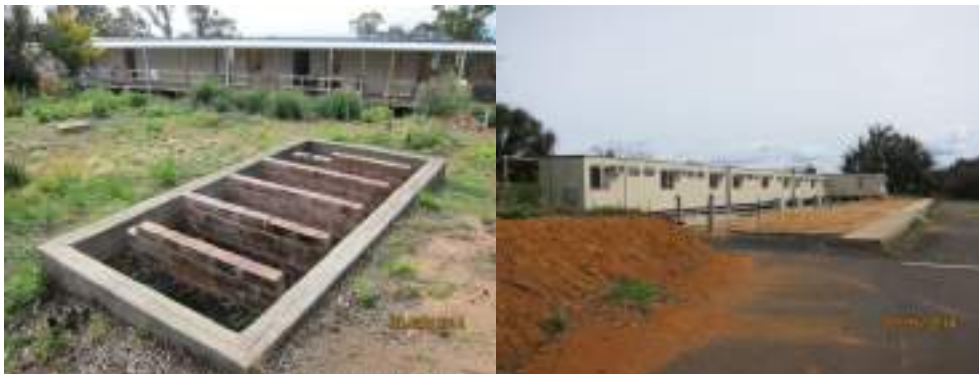
ANU ID Number	<b>N006, N013</b>
HMP Number	<b>006</b>
Type	<b>Accommodation</b>
Ownership	<b>ANU</b>
Management	<b>ANU</b>
Status	<b>Destroyed by 2013 Bushfire</b>
Date constructed/ installed	<b>1964-65 (Additional Lodge built c1968)</b>
Level of significance	<b>Low</b>

Destroyed by the bushfire of January 2013. Foundations condition unclear as currently obscured by temporary lodge.

Need for permanent replacement

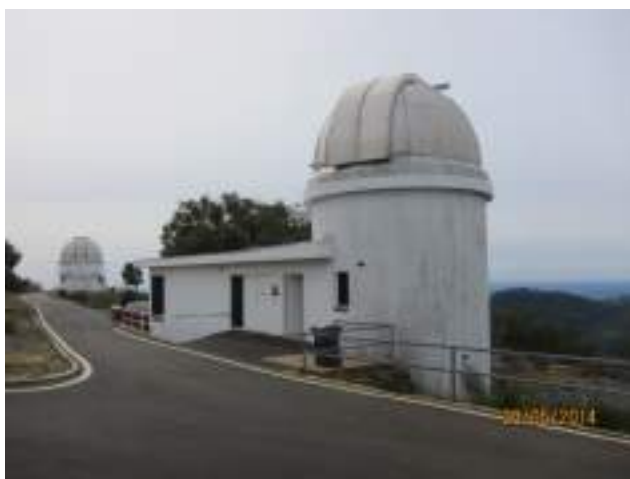
ANU ID Number	<b>N007</b>
HMP Number	<b>007</b>
Type	<b>Telescope</b>
Ownership	<b>ANU</b>
Management	<b>ANU</b>
Status	<b>Redundant (telescope only - offices remain in use)</b>
Date constructed/ installed	<b>1966</b>
Level of significance	<b>High</b>

The building appears to be in good condition with some ephermeral external ware including peeling paint. Aluminising plant room and new office section operational

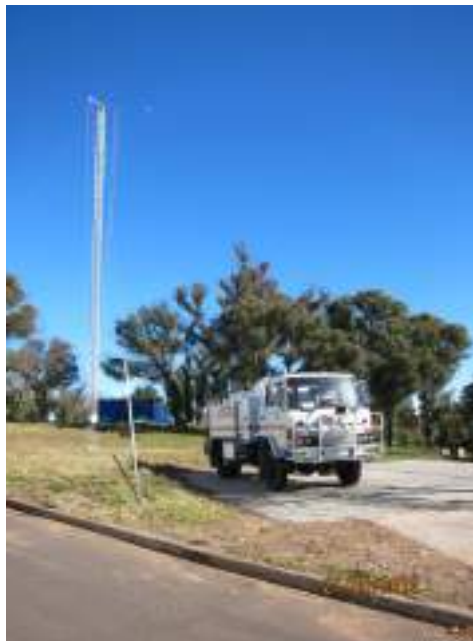
ANU ID Number	<b>N010</b>
HMP Number	<b>009</b>
Type	<b>Infrastructure</b>
Ownership	<b>ANU</b>
Management	<b>ANU</b>
Status	<b>Destroyed by 2013 Bushfire</b>
Date constructed/ installed	<b>Not known</b>
Level of significance	<b>Low</b>

The fire station building was destroyed by the 2013 bushfire. The steel hose-mast and the concrete foundation pad remain.

Destroyed by the bushfire of January 2013, extant foundations in fair condition.

Need for permanent replacement

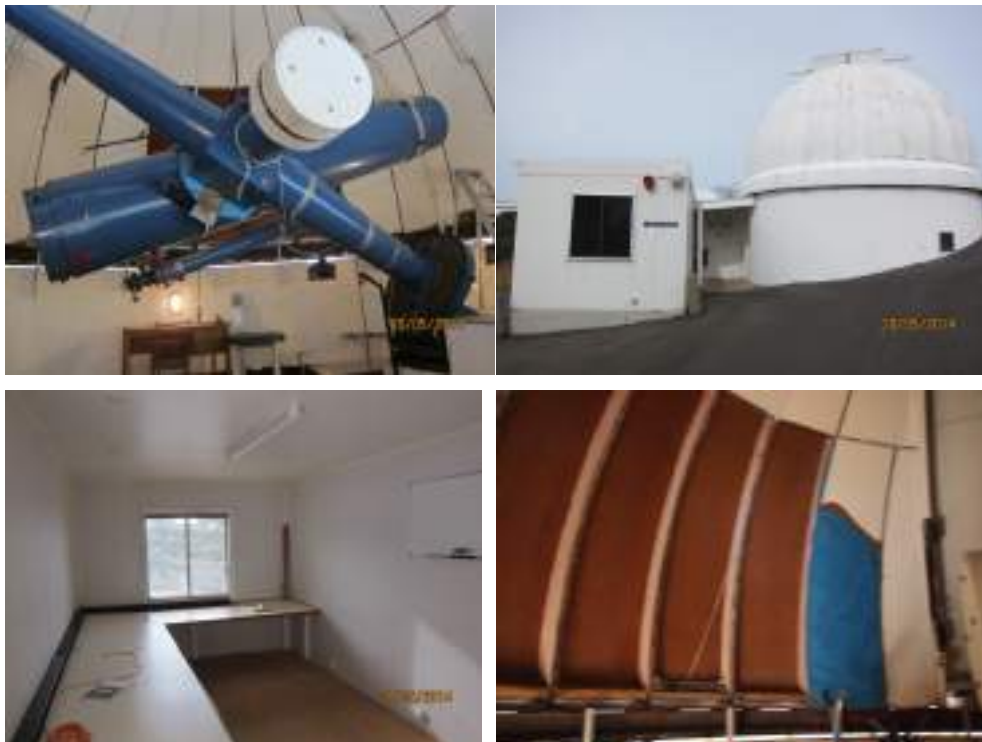
ANU ID Number	<b>N011</b>
HMP Number	<b>0010</b>
Type	<b>Telescope</b>
Ownership	<b>ANU</b>
Management	<b>ANU</b>
Status	<b>Redundant</b>
Date constructed/ installed	<b>1956, moved to SSO in 1982</b>
Level of significance	<b>High</b>

A simple telescope building comprising a dome mounted on a low circular rendered concrete foundation wall. Within this wall, the wooden floor of the single chamber is supported on a series of cemented brick piers. The dome, and the large pulley-driven shutter which covers the aperture within it, are of timber frame construction lined inside and out with Masonite panels and externally clad with aluminium sheeting. When operational the dome was rotated by means of a rail at its base which is supported on a series of spring-loaded bogies set in the wall, held in place by metal brackets and driven by a single electric motor. A metal ‘skirt’ running around the dome shields the resulting gap between the rail and the wall from the elements. The viewing chamber contains several pieces of furniture, of which some, including a ‘mirror box’, contain telescope components. Otherwise it is sparsely equipped with generic power and lighting fittings. The equatorial mounting of the telescope remains although the telescope itself appears to have been removed. The viewing chamber is reached via a short wooden stair from a single external door, adjacent to which is a hatch into a crawl space amongst the brick foundation piers. The door opens onto a small porch which also covers the entrance to a prefabricated aluminium (?) control room. This structure, which is lined with fibro-cement sheeting, represents a later addition and is now entirely empty except for a wooden bench running along two sides and a white board.

The build quality of the structure is fairly poor compared to the earlier telescope buildings to the west, and the structure has deteriorated. The wooden frame and internal panels of the dome in particular are in poor condition, and several have been removed.

Both components of the structure are disused and reuse is currently unlikely because of the condition of the dome. Given that the telescope was only decommissioned in late 2013, the deterioration would appear to have been rapid, and this poses a significant risk.

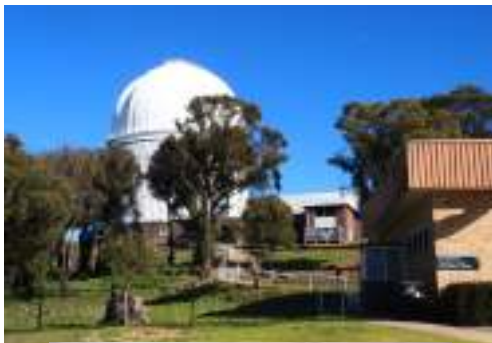
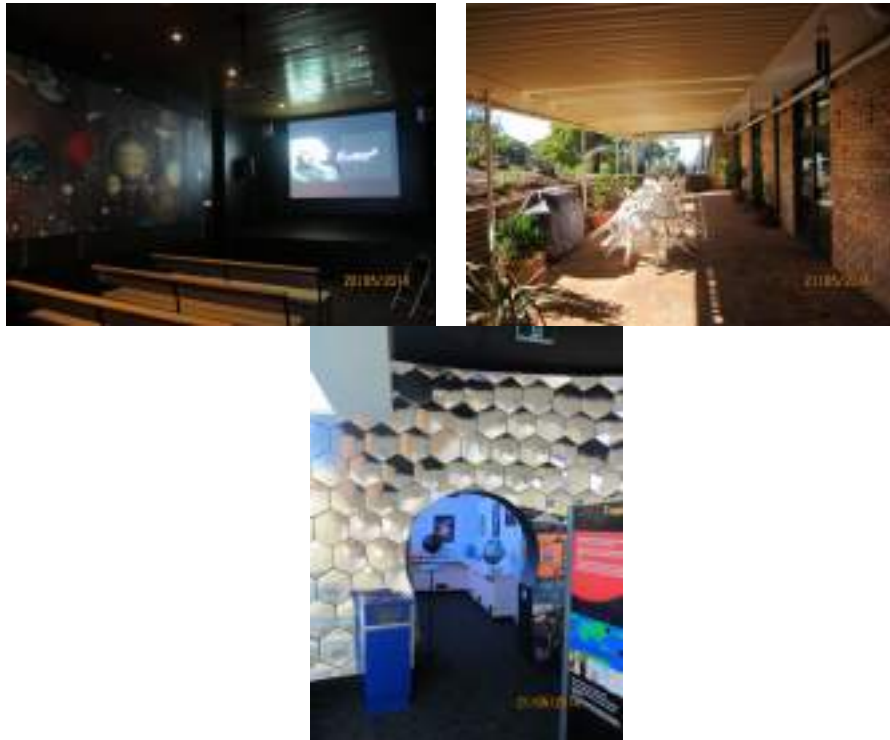
ANU ID Number	<b>N015</b>
HMP Number	<b>013</b>
Type	<b>Visitors Centre/Exploratory</b>
Ownership	<b>ANU</b>
Management	<b>ANU</b>
Status	<b>Active</b>
Date constructed/ installed	<b>1974</b>
Level of significance	<b>Moderate</b>

Fair condition generally although the interior including the exhibition now appears dated.

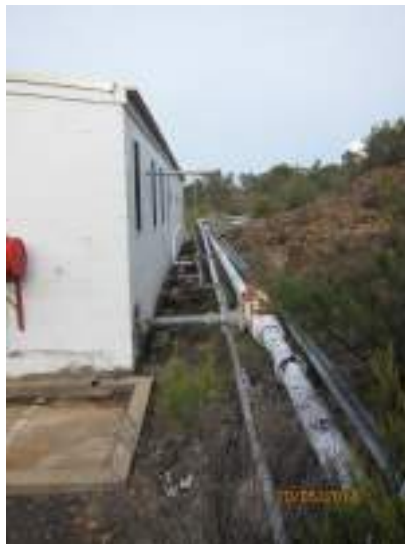
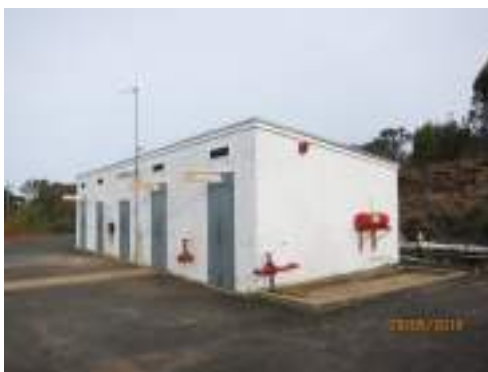
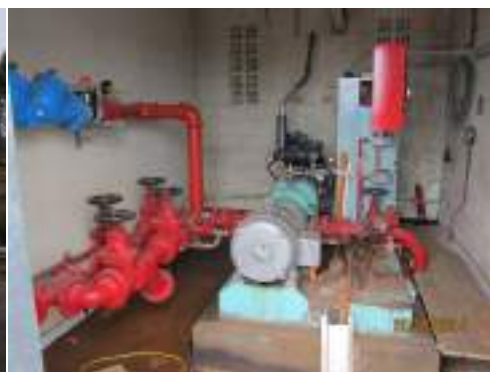
ANU ID Number	<b>N020</b>
HMP Number	<b>017</b>
Type	<b>Infrastructure</b>
Ownership	<b>ANU</b>
Management	<b>ANU</b>
Status	<b>Active</b>
Date constructed/ installed	<b>c1975</b>
Level of significance	<b>Low</b>

This facility is vital to the functioning of the site, and it is thus maintained in good operational condition.

Some of the equipment may be approaching the end of its operational life, in which case it will need to be replaced.
