Asbestos Incident Inspection

Asbestos Incident Inspection (NOT FOR CONSTRUCTION)			
Report No :	06032017-01 Ver3		
Address:	Jaeger Building 1, Building 61 ANU Action ACT		
Prepared & Approved By :	<table border="1" style="width: 100%;"> <tr> <td style="width: 30%;">B.Williams LAA000169</td> <td style="width: 70%; text-align: center;"> </td> </tr> </table>	B.Williams LAA000169	 
B.Williams LAA000169	 		
Date of Sampling:	<p>6th March 2017</p> <p>9th March 2017 Ver 2</p> <p>15 March 2017 Ver 3</p>

Re: Room B6 Jaeger Building 1, Building 1 ANU Acton ACT

Ref: 06032017-01 Ver 3

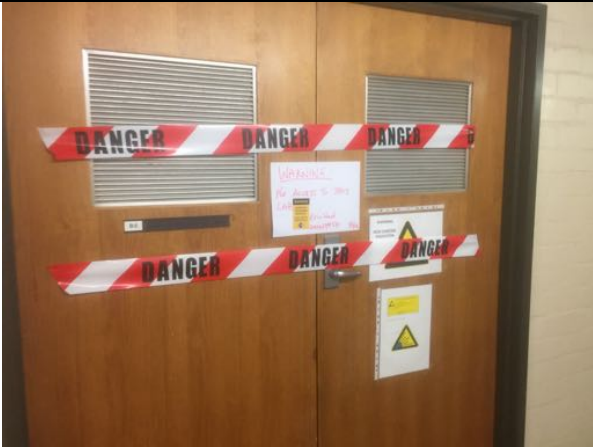
Fig 1

ANU Staff as precaution erected signage on the doors & restricted access. (fig 1)

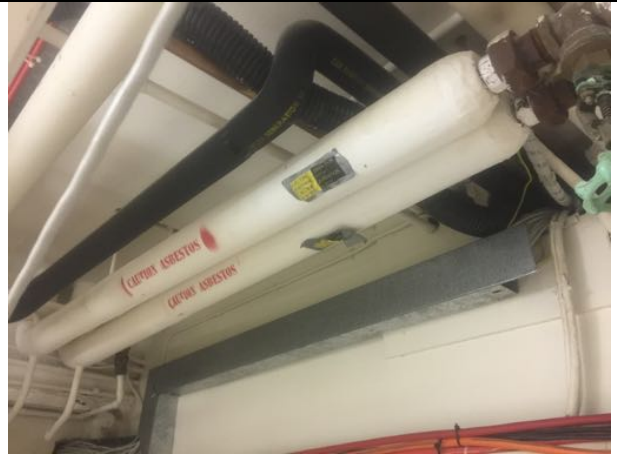
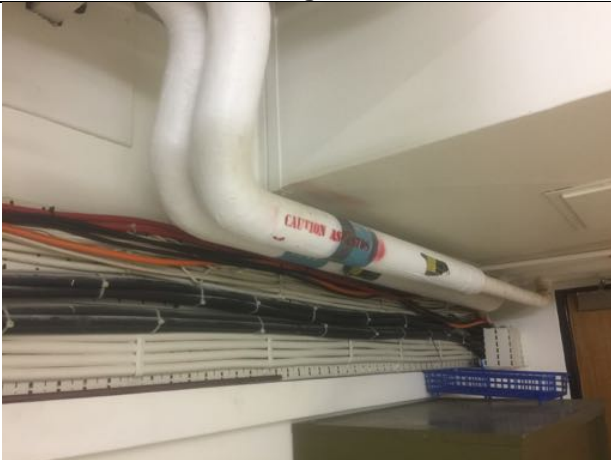
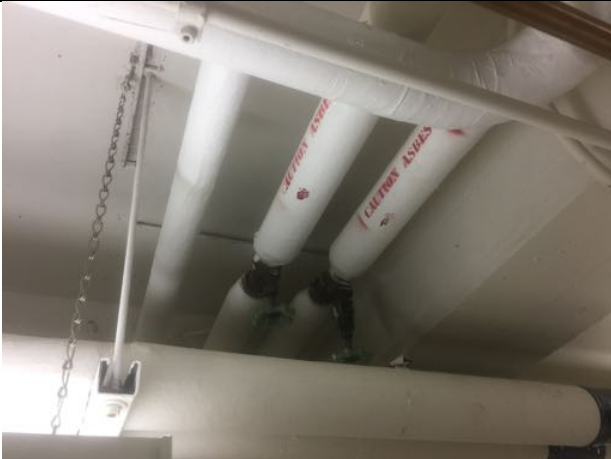
The inspection found that several sections of the pipe lagging in the room was Asbestos, these were found to be clearly labeled (fig 2 to 5)

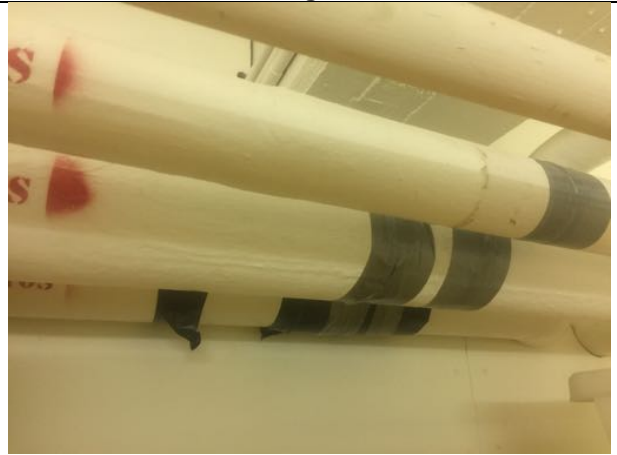
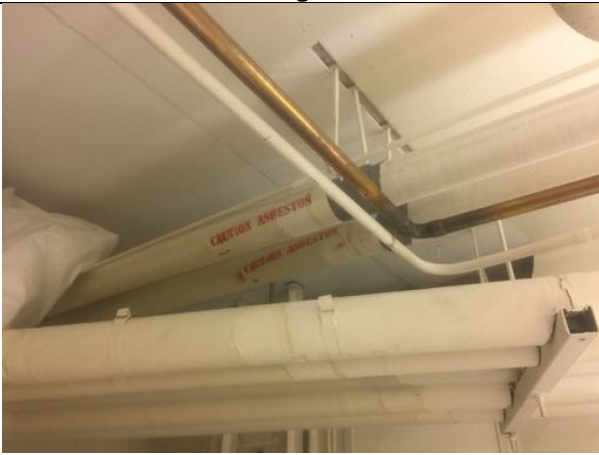
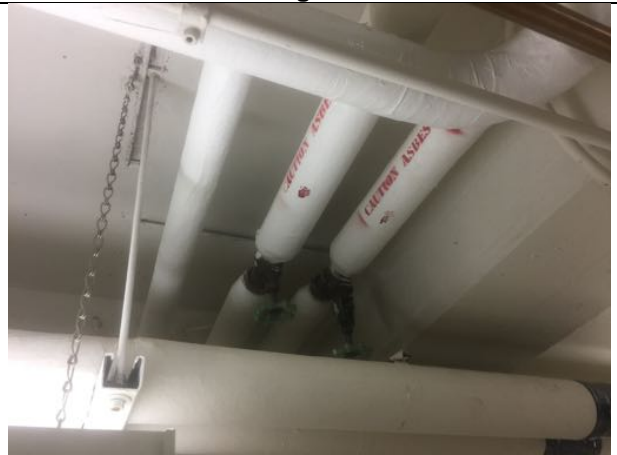
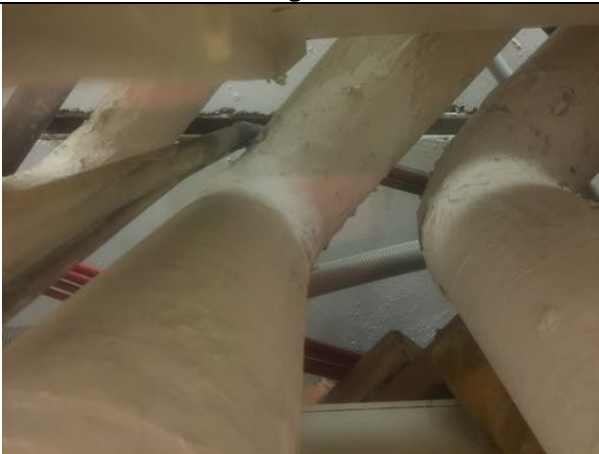
Several areas of the pipe lagging was found in a poor/damaged condition, areas around the hangers & joins were visibly damaged. (fig 6 to 11)

- Wrap reinforced silver tape to encapsulated all sections of pipe that have exposed ends, damage or where pipe hangers are penetrating the insulation.

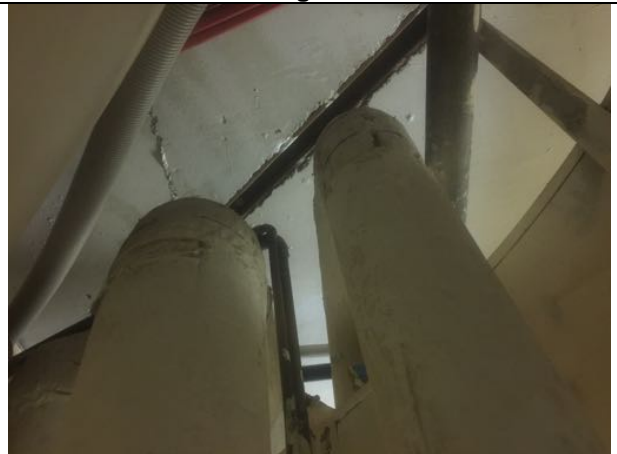
Fig 12

A section above the entry door marked B4a was found to be unwrapped with cloth, exposing visible fibres. (fig 12)

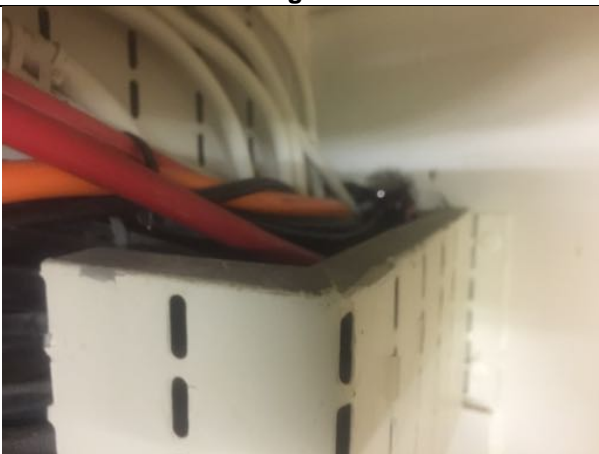
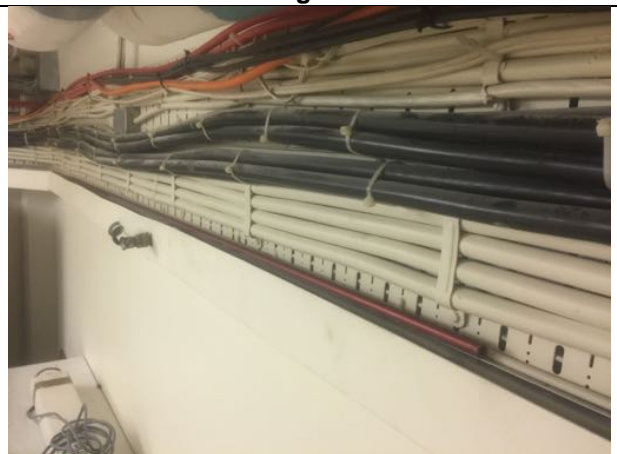
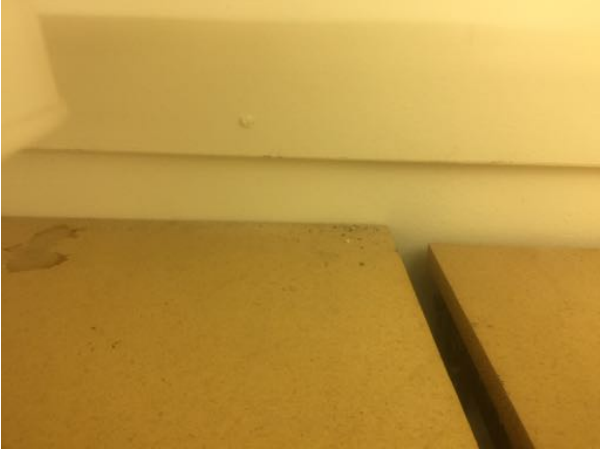
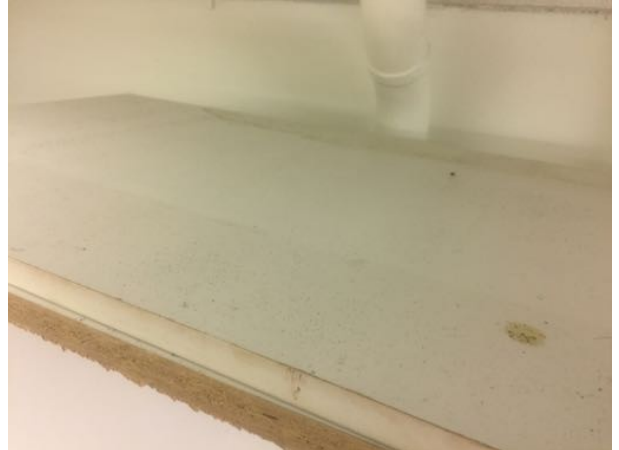
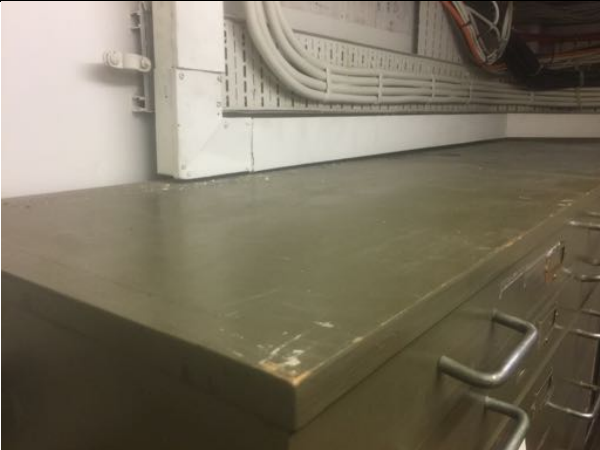
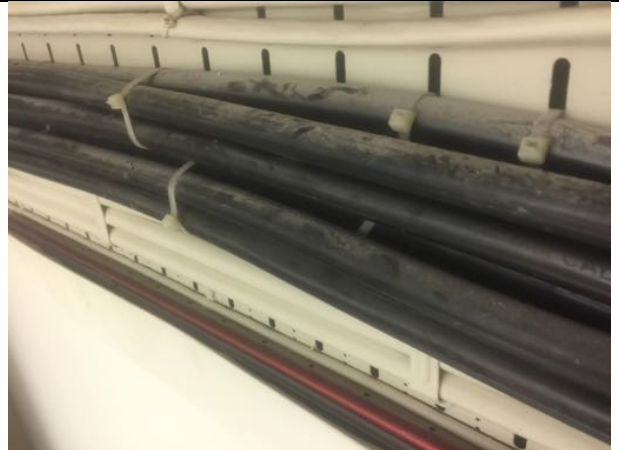
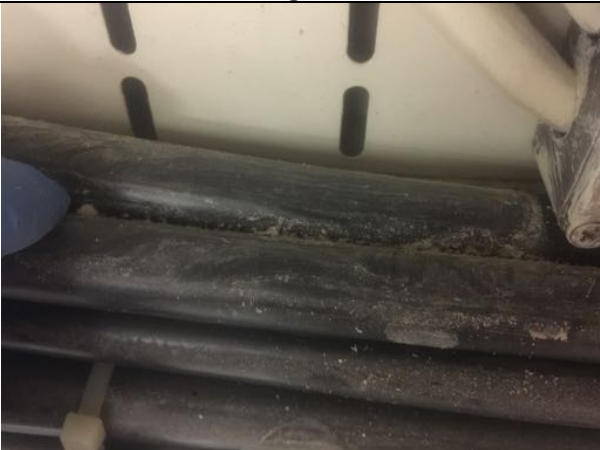
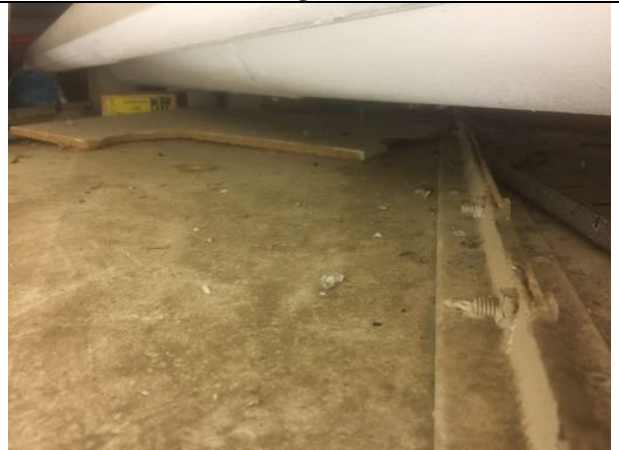
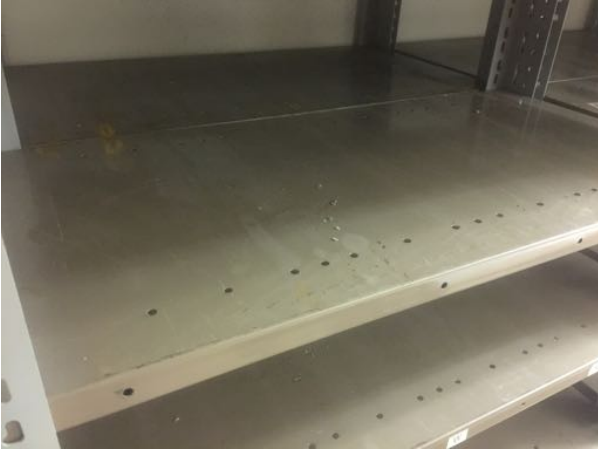
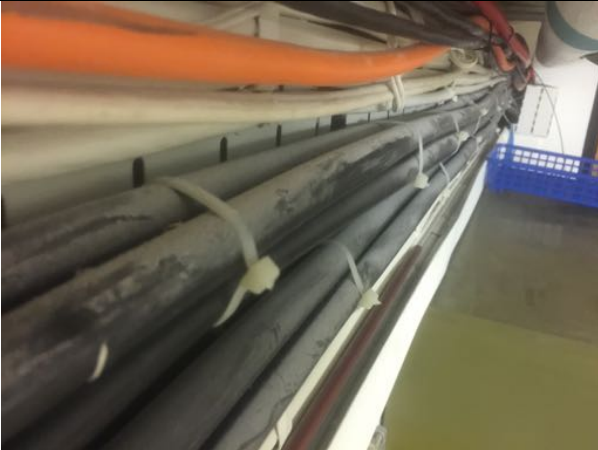
Dust & debris was visible throughout the room below areas where the asbestos pipe lagging was in a poor condition, sampling was conducted in 6 sections of the room to check for the presence of loose asbestos fibres in the dust. (fig 13 to 23)

- Remove & dispose of all loose items & all porous materials present in the room as contaminated waste in marked 200um bags or wrapped in 200um plastic.

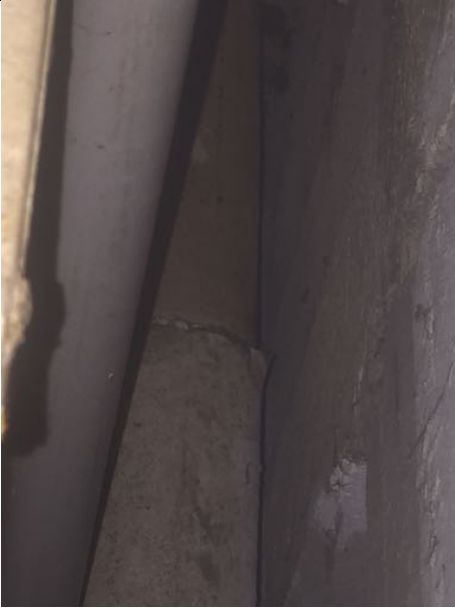
Room B7	
Fig 47

**Room B7
(fig 47)**

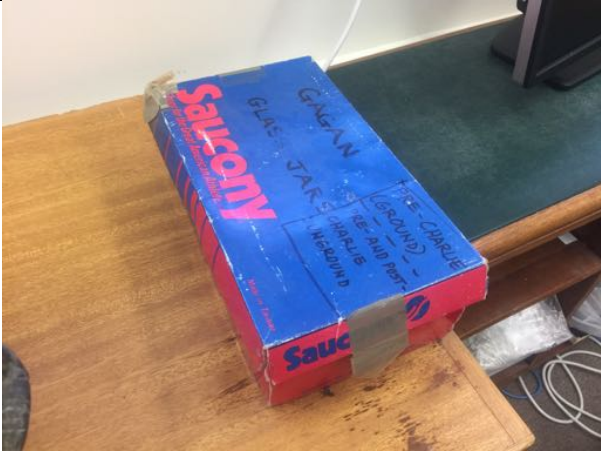
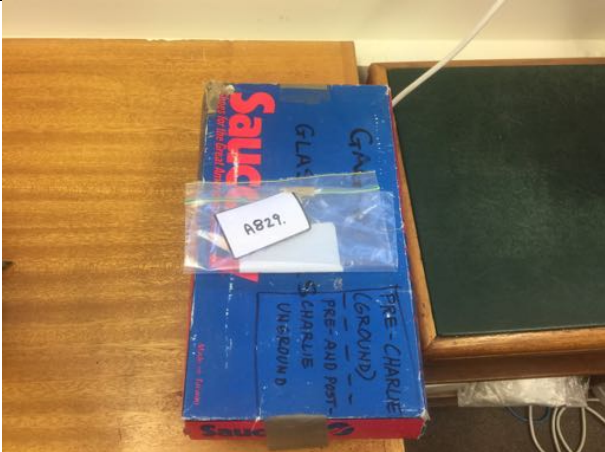
Sample Number				A829		
Date of Sampling				9 th March 2017		
Location of Sampling				Room G22 Dust off shoe box.		
Sample Result				No Asbestos Detected in sampled area		
Sample Risk Score				-		
Asbestos Fibre Type	Surface Treatment	Product Type	Extent of Damage	Likelihood of Disturbance	Risk	Action Rating
-	-	-	-	-	-	-
Comments & Recommendations				Nil		
Sample Photos

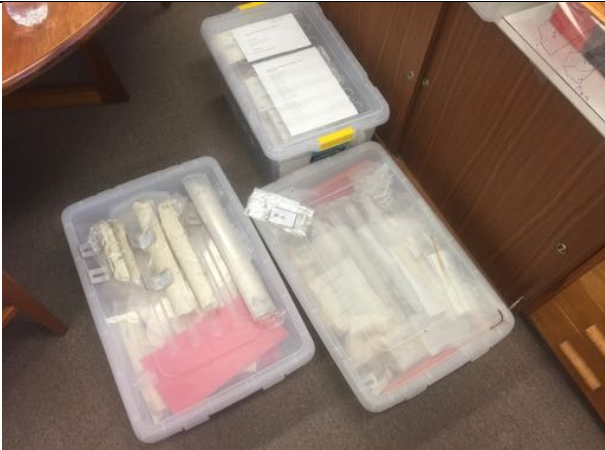
Sample Number				A830		
Date of Sampling				9 th March 2017		
Location of Sampling				Room G22 Dust off stored		
Sample Result				No Asbestos Detected in sampled area		
Sample Risk Score				-		
Asbestos Fibre Type	Surface Treatment	Product Type	Extent of Damage	Likelihood of Disturbance	Risk	Action Rating
-	-	-	-	-	-	-
Comments & Recommendations				Nil		
Sample Photos

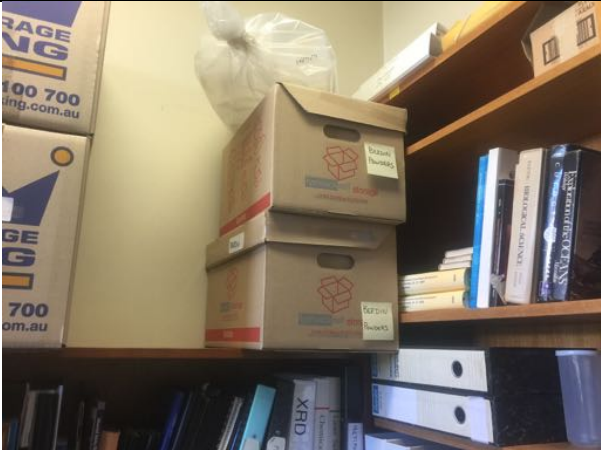
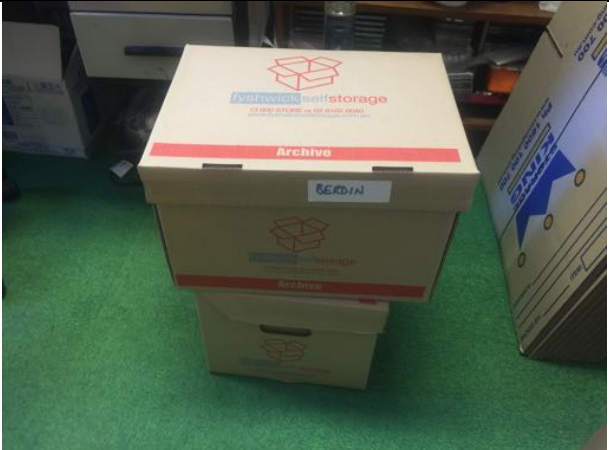
Sample Number		A832				
Date of Sampling		9 th March 2017				
Location of Sampling		Room G14 Dust off boxes "Berdin"				
Sample Result		No Asbestos Detected in sampled area				
Sample Risk Score		-				
Asbestos Fibre Type	Surface Treatment	Product Type	Extent of Damage	Likelihood of Disturbance	Risk	Action Rating
-	-	-	-	-	-	-
Comments & Recommendations			Nil			
Sample Photos

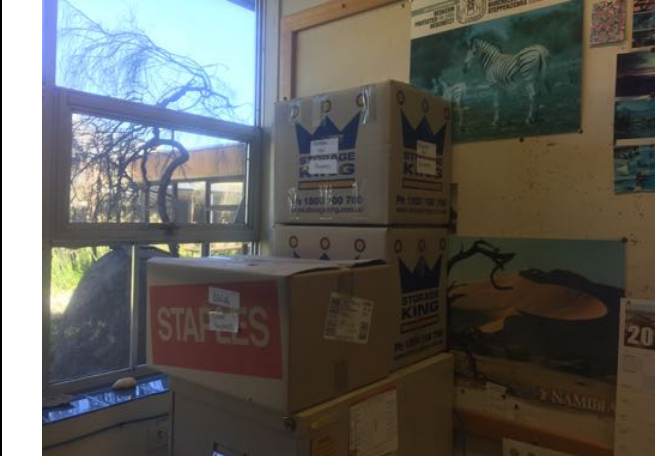
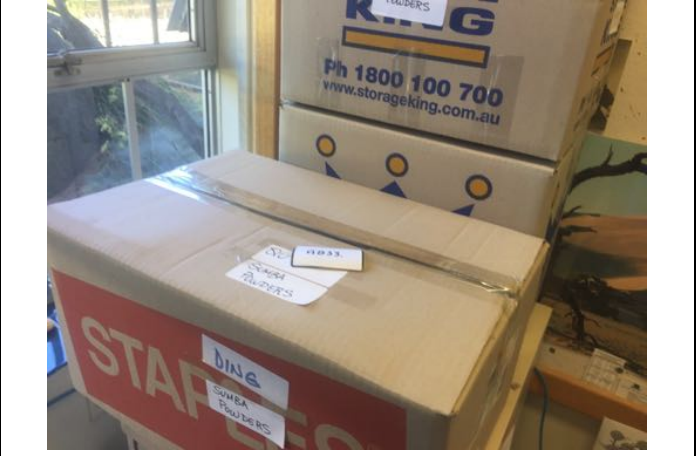
Sample Number		A833				
Date of Sampling		9 th March 2017				
Location of Sampling		Room G14 Dust off boxes "Sumba"				
Sample Result		No Asbestos Detected in sampled area				
Sample Risk Score		-				
Asbestos Fibre Type	Surface Treatment	Product Type	Extent of Damage	Likelihood of Disturbance	Risk	Action Rating
-	-	-	-	-	-	-
Comments & Recommendations			Nil			
Sample Photos

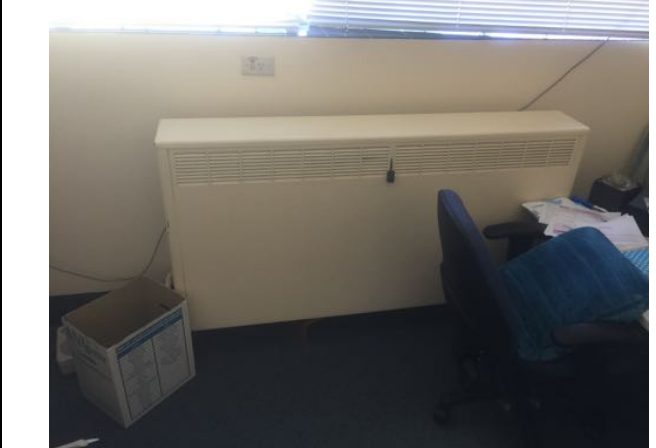
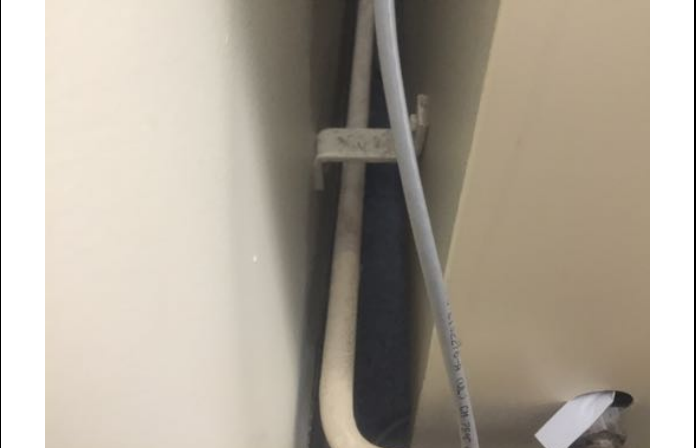
Sample Number		A834				
Date of Sampling		9 th March 2017				
Location of Sampling		Room G13 Dust Behind Heater				
Sample Result		No Asbestos Detected in sampled area				
Sample Risk Score		-				
Asbestos Fibre Type	Surface Treatment	Product Type	Extent of Damage	Likelihood of Disturbance	Risk	Action Rating
-	-	-	-	-	-	-
Comments & Recommendations			Nil			
Sample Photos

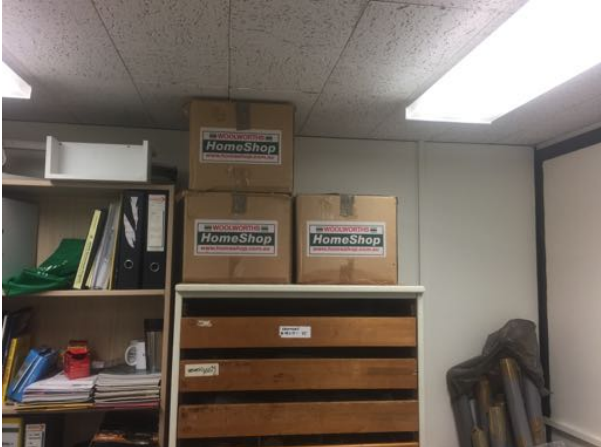
Sample Number				A835		
Date of Sampling				9 th March 2017		
Location of Sampling				Room L29 Dust off boxes "homeshop"		
Sample Result				No Asbestos Detected in sampled area		
Sample Risk Score				-		
Asbestos Fibre Type	Surface Treatment	Product Type	Extent of Damage	Likelihood of Disturbance	Risk	Action Rating
-	-	-	-	-	-	-
Comments & Recommendations						
Sample Photos

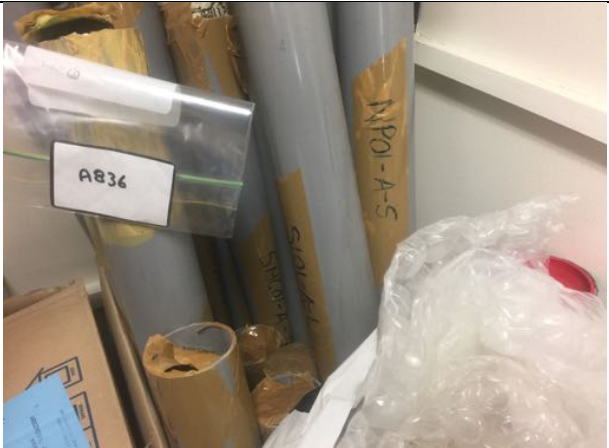
Sample Number				A836		
Date of Sampling				9 th March 2017		
Location of Sampling				Room L29 dust off tubes		
Sample Result				No Asbestos Detected in sampled area		
Sample Risk Score				-		
Asbestos Fibre Type	Surface Treatment	Product Type	Extent of Damage	Likelihood of Disturbance	Risk	Action Rating
-	-	-	-	-	-	-
Comments & Recommendations				Nil		
Sample Photos

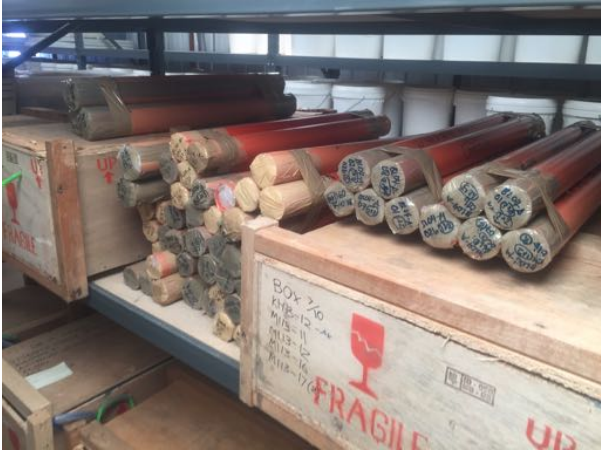
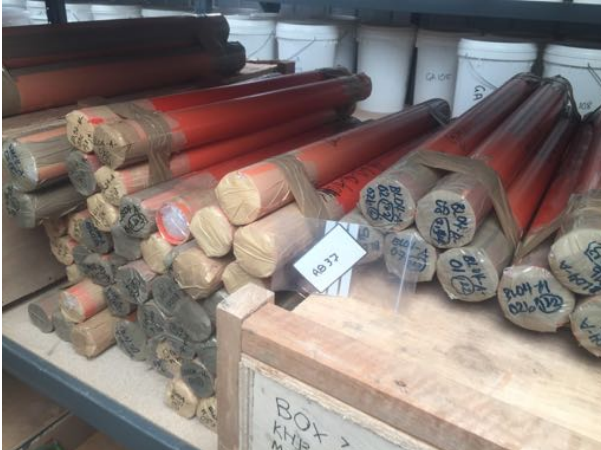
Sample Number				A837			
Date of Sampling				9 th March 2017			
Location of Sampling				Black Mountain Dust off tubes "BL04"			
Sample Result				No Asbestos Detected in sampled area			
Sample Risk Score				-			
Asbestos Fibre Type	Surface Treatment	Product Type	Extent of Damage	Likelihood of Disturbance	Risk	Action Rating	
-	-	-	-	-	-	-	
Comments & Recommendations				Nil			
Sample Photos

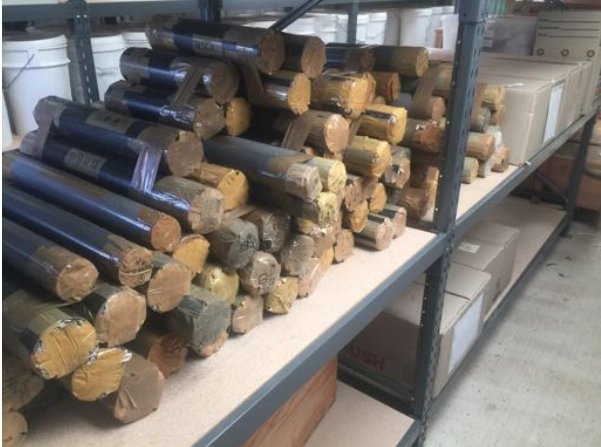
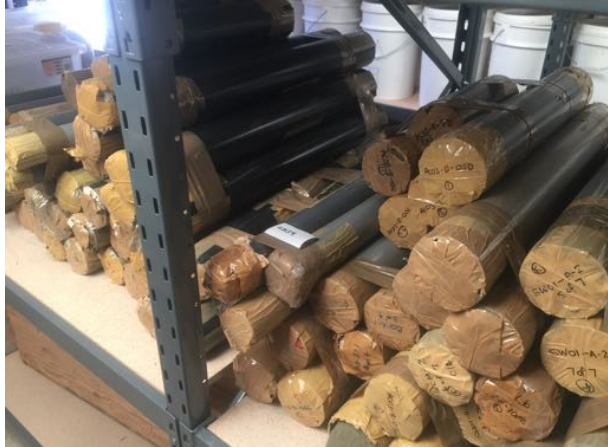
Sample Number		A839				
Date of Sampling		9 th March 2017				
Location of Sampling		Black Mountain Dust off tubes grey				
Sample Result		No Asbestos Detected in sampled area				
Sample Risk Score		-				
Asbestos Fibre Type	Surface Treatment	Product Type	Extent of Damage	Likelihood of Disturbance	Risk	Action Rating
-	-	-	-	-	-	-
Comments & Recommendations			Nil			
Sample Photos

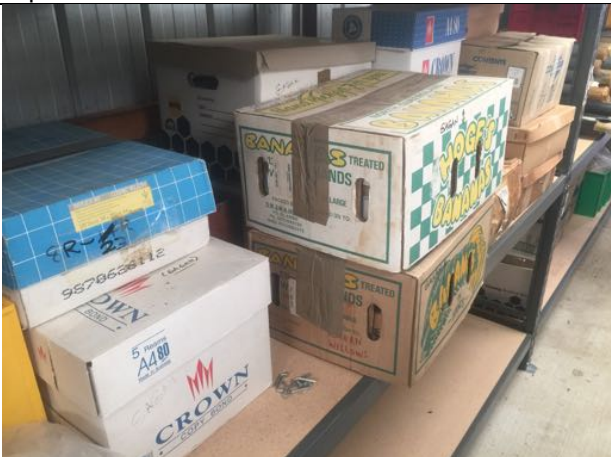
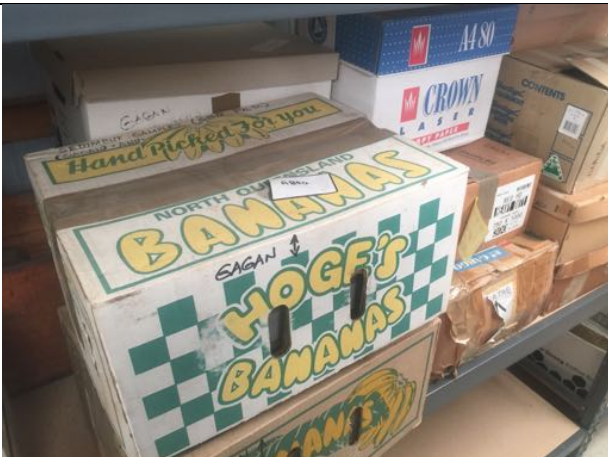
Sample Number		A840				
Date of Sampling		9 th March 2017				
Location of Sampling		Black Mountain Dust off boxes "Gagan"				
Sample Result		No Asbestos Detected in sampled area				
Sample Risk Score		-				
Asbestos Fibre Type	Surface Treatment	Product Type	Extent of Damage	Likelihood of Disturbance	Risk	Action Rating
-	-	-	-	-	-	-
Comments & Recommendations			Nil			
Sample Photos
